## FEASIBILITY REPORT

### 2025 MAPLEWOOD STREET IMPROVEMENTS CITY PROJECT, 24-12

## 2025 MAPLEWOOD STREET IMPROVEMENTS CITY PROJECT 24-12

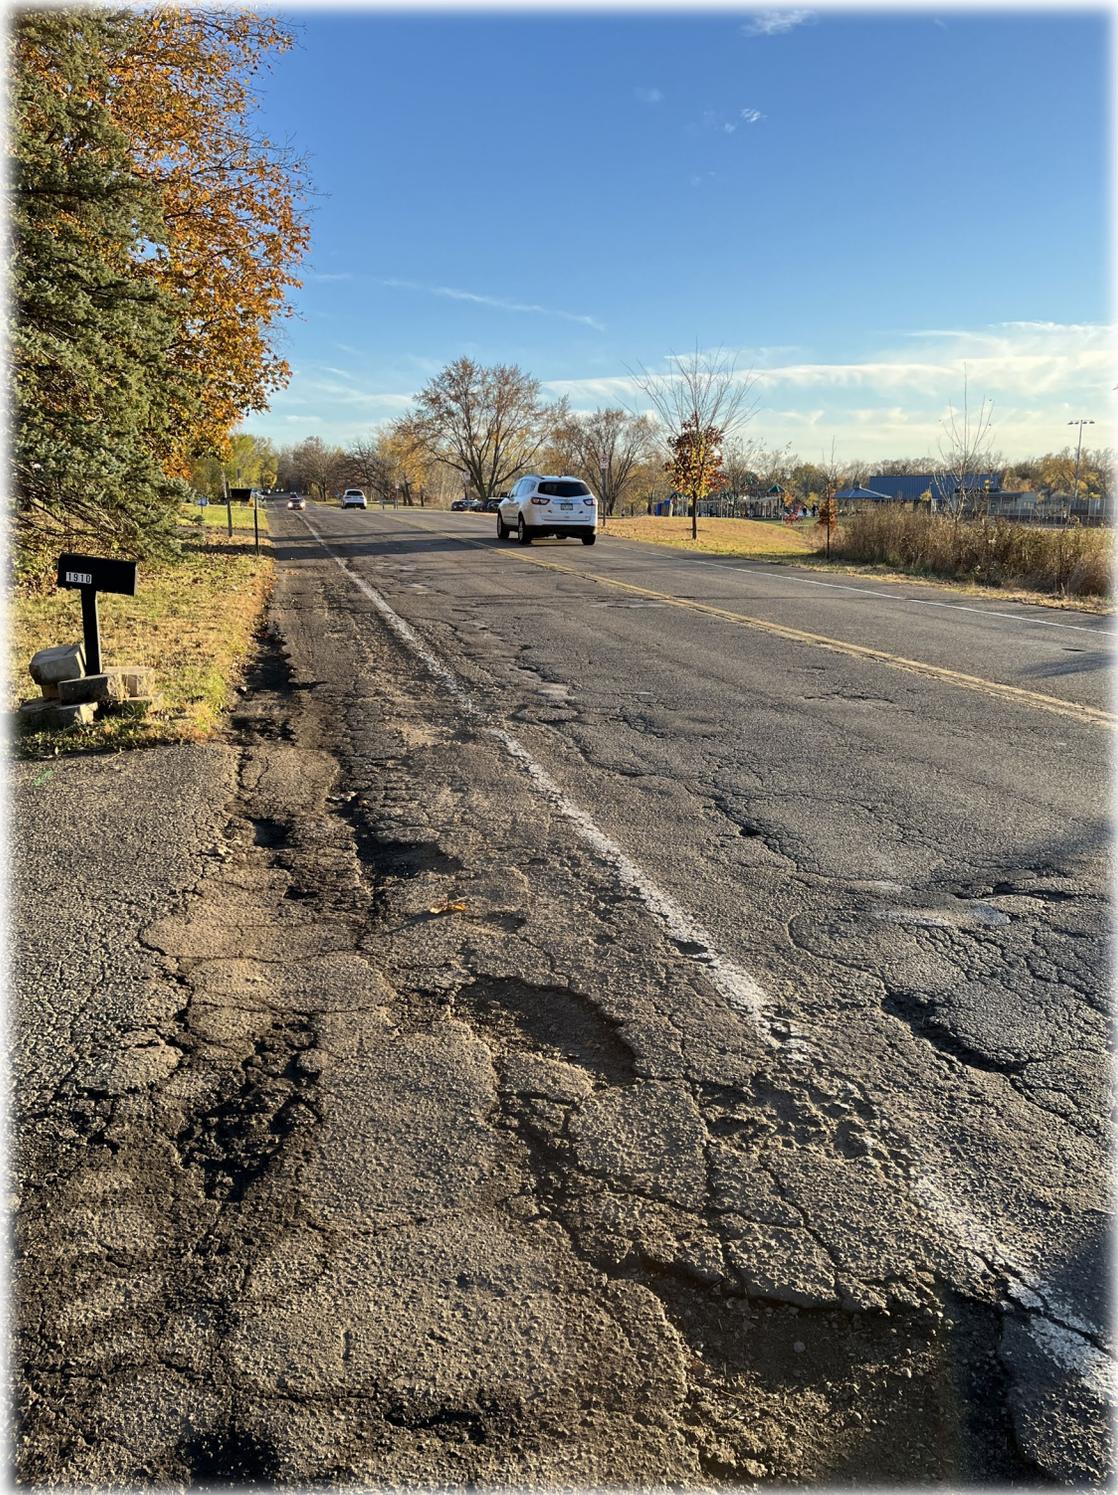
**Prosperity Road**

The existing streets have failures including, but not limited to, transverse and edge cracking, medium to high severity patching, fatigue (alligator) cracking, block cracking and many potholes which need patching yearly. A number of areas within the street section have water pooling in them as well. These puddles undergo freeze thaw cycles in the winter, which deteriorates the pavement at a faster rate. Figures 1 - 8 on the following pages display pictures of the level of pavement deterioration on these streets. The pictures provide an accurate representation of the current state of pavement condition throughout the neighborhood.

*FIGURE 1: Pavement Condition Photos*

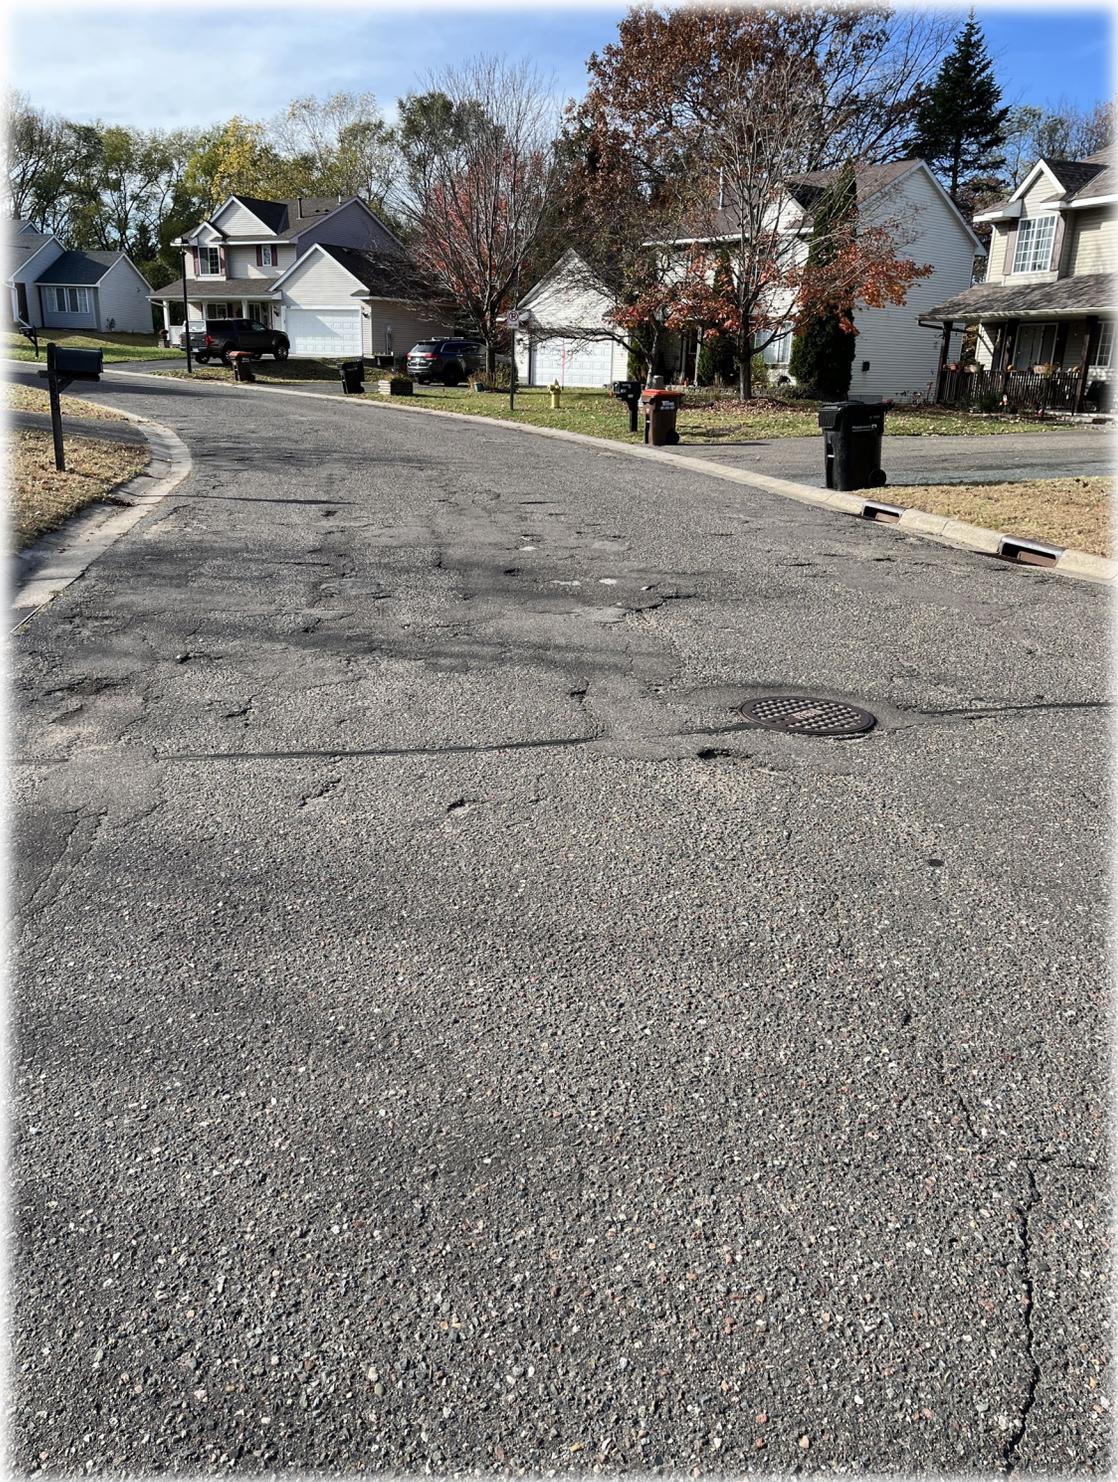
Parkview Lane

*FIGURE 2: Pavement Condition Photos*

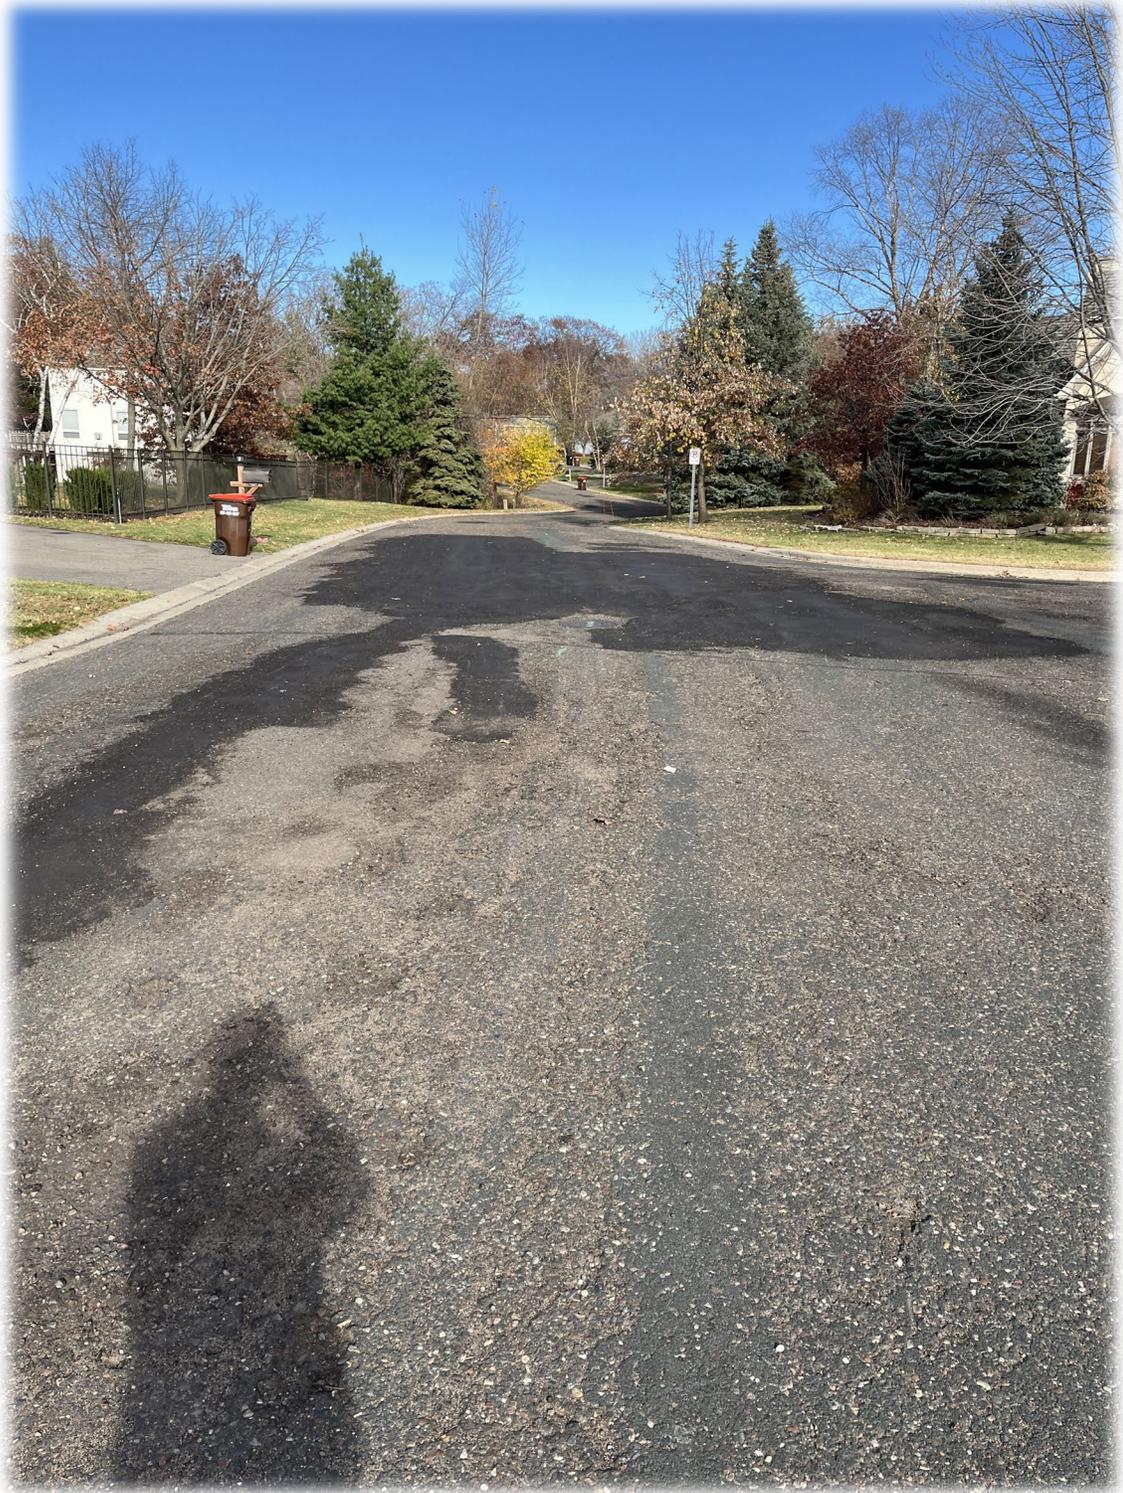
**Hillwood Drive**

*FIGURE 3: Pavement Condition Photos*

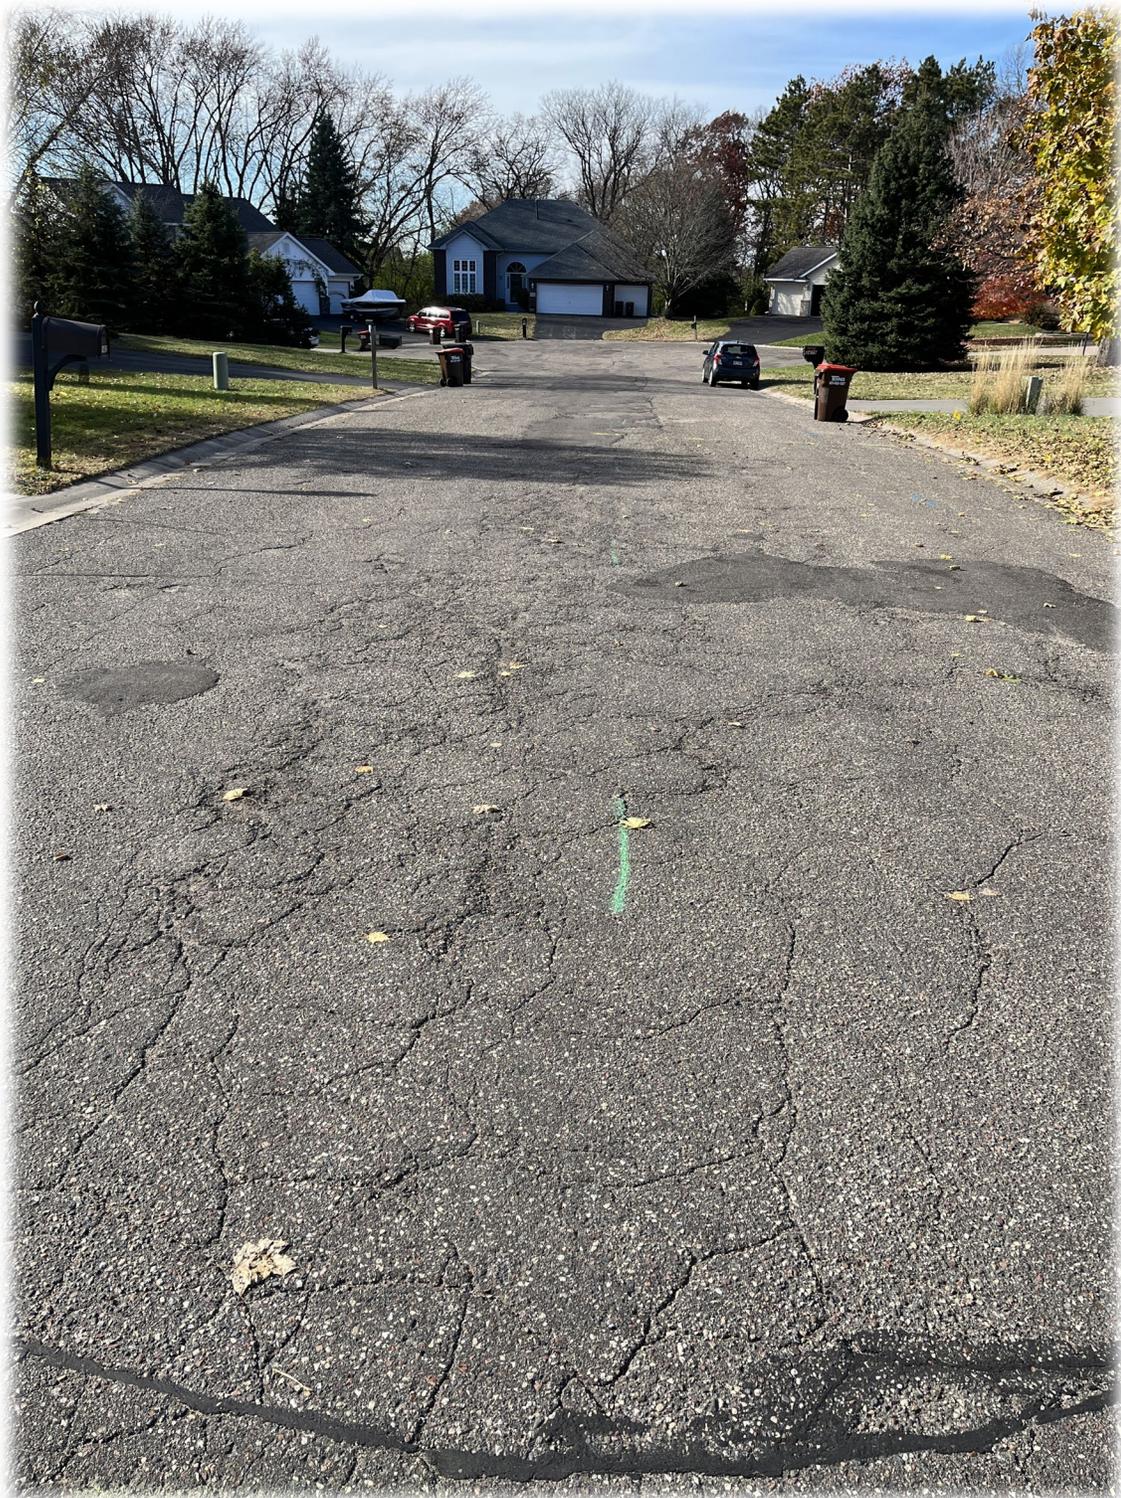
**Timber Court**

*FIGURE 4: Pavement Condition Photos*

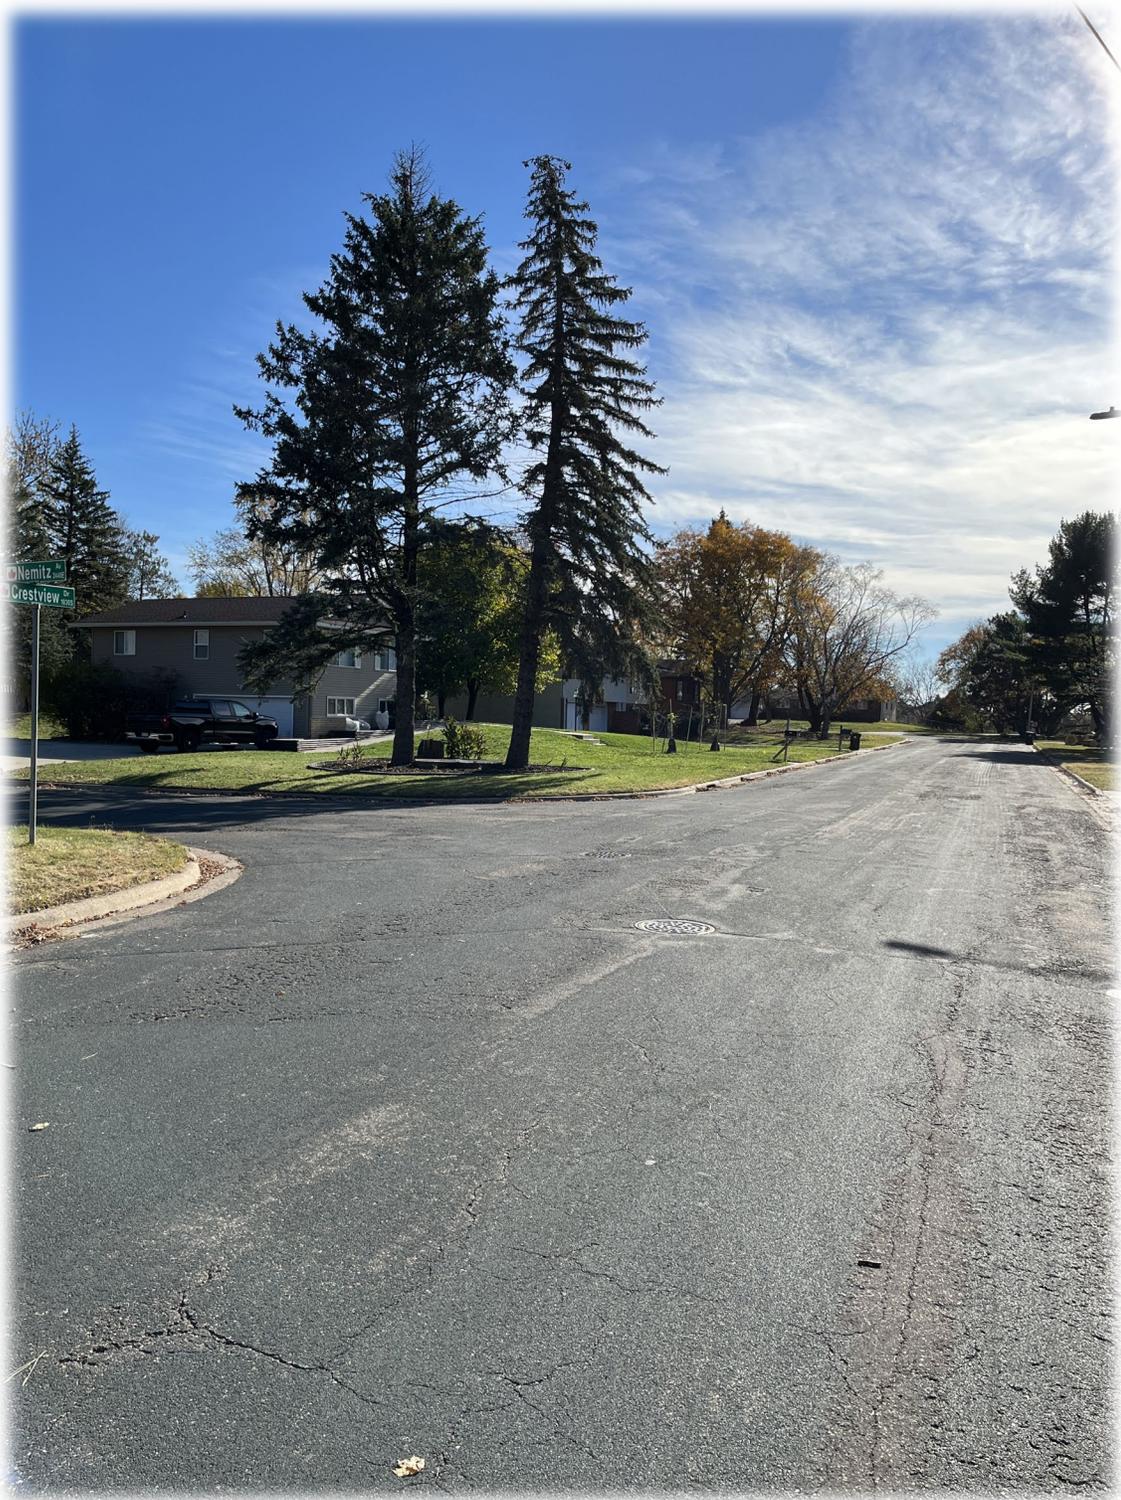
Crestview Drive

*FIGURE 5: Pavement Condition Photos*

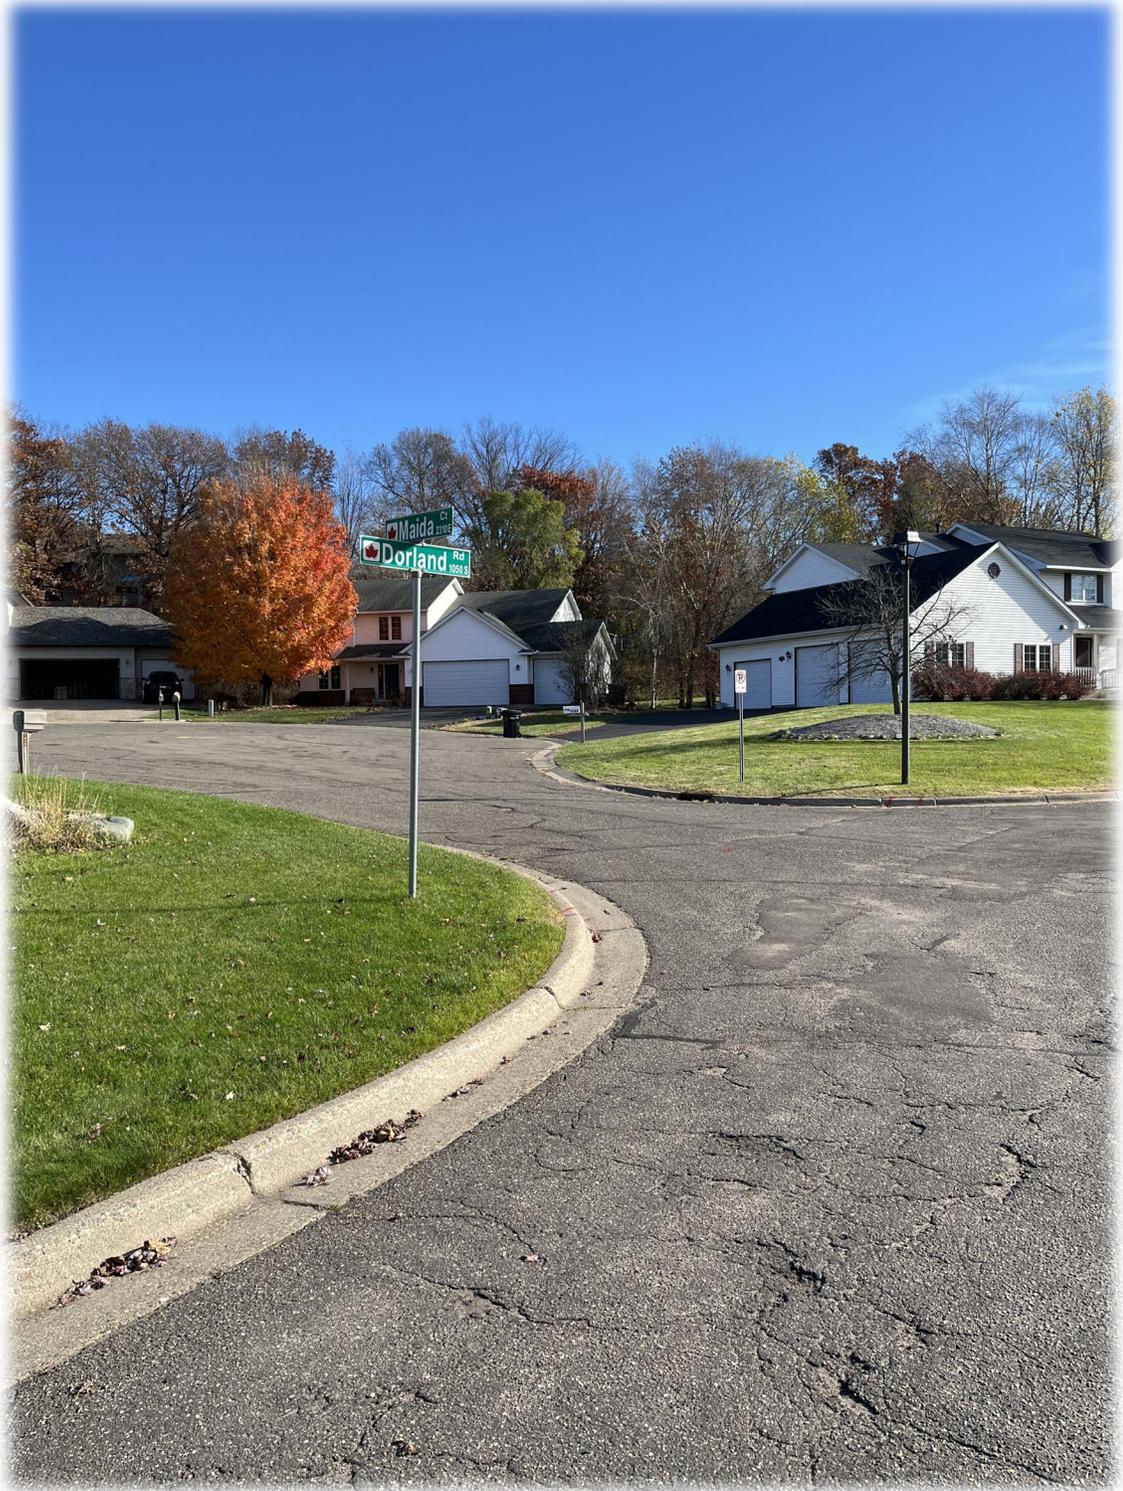
**Maida Court/Dorland Road**

*FIGURE 6: Pavement Condition Photos*

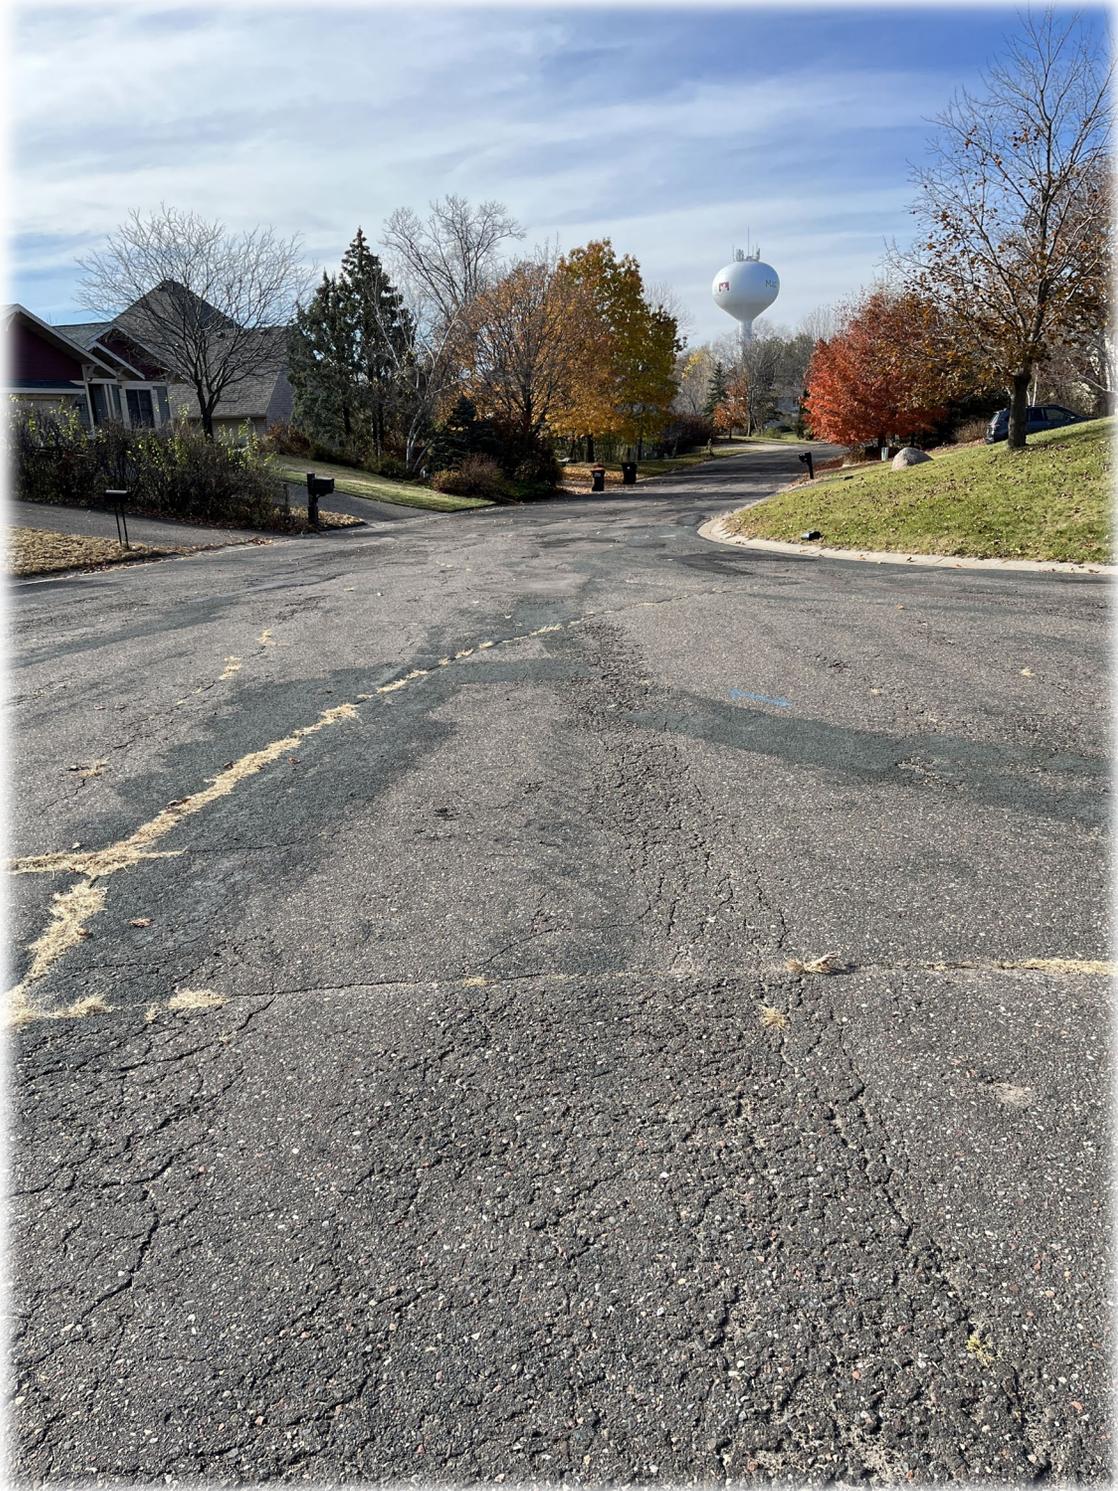
**Oakridge Court**

*FIGURE 7: Pavement Condition Photos*

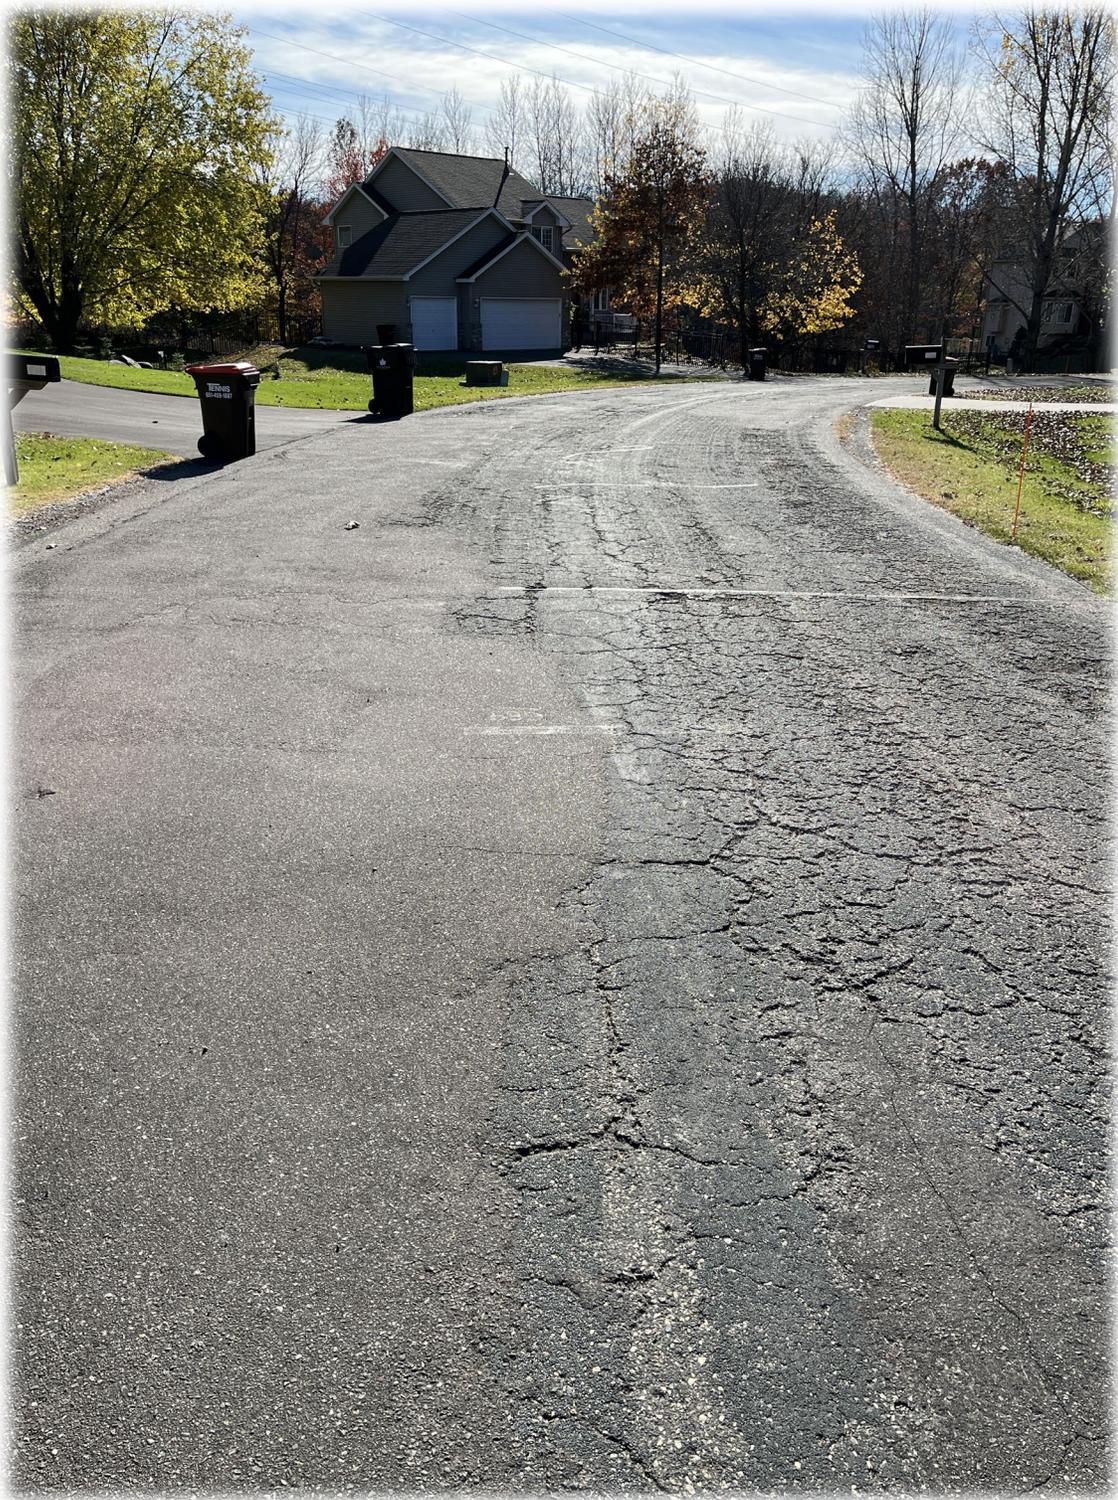
**Haller Lane**

*FIGURE 8: Pavement Condition Photos*
