**UPDATED REPORT OF:  
ASBESTOS AND REGULATED MATERIAL INSPECTION**

**FORMER MOOSE  
1946 ENGLISH STREET  
ST. PAUL, MN**

**LEGEND No. 2405158**

**January 7, 2025**

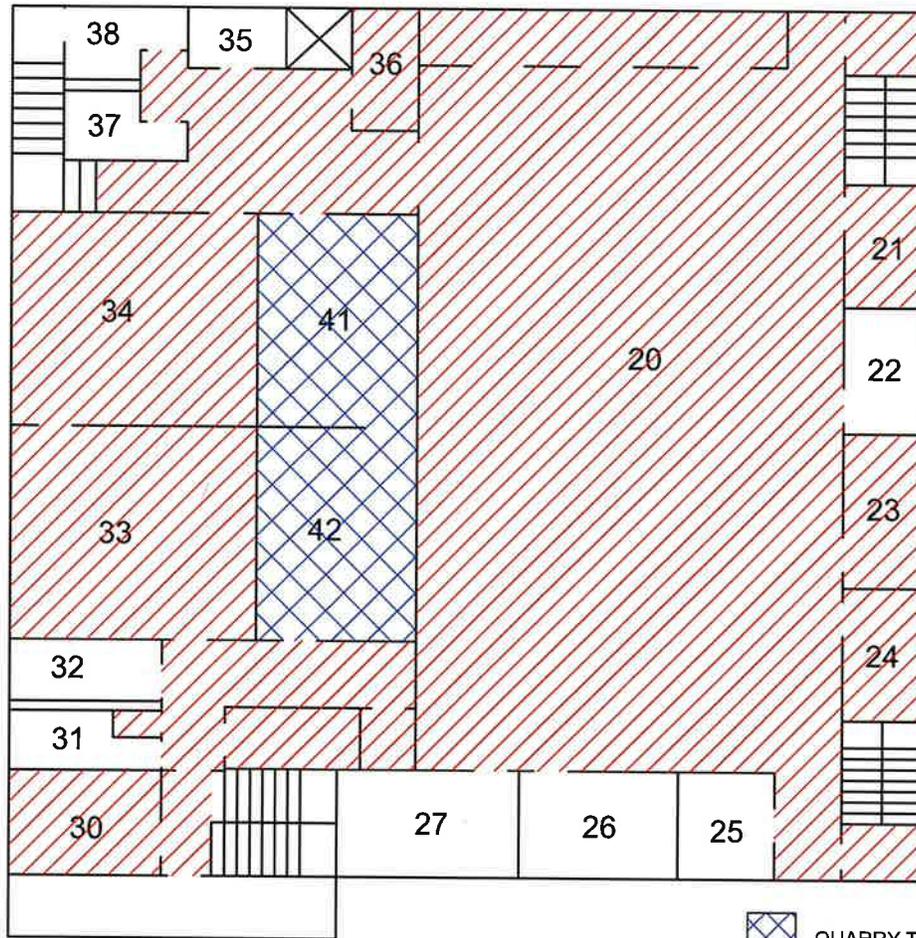
DIAGRAM #4  
ASBESTOS FLOORING LOCATIONS

All variations of the vinyl floor tiles in the building with the exception of some replacement tile on the upper level were determined to contain asbestos. All variations of black, floor tile mastic was determined to contain asbestos (including mastic beneath replacement tiles and quarry tiles). Many of the floor tiles were damaged and brittle and will become friable during removal and/or demolition and therefore need to be removed prior to demolition. The mastics are considered a non-friable asbestos material in their current condition however could become friable during removal and/or demolition.

LOWER LEVEL

-ASBESTOS FLOOR TILE AND MASTIC

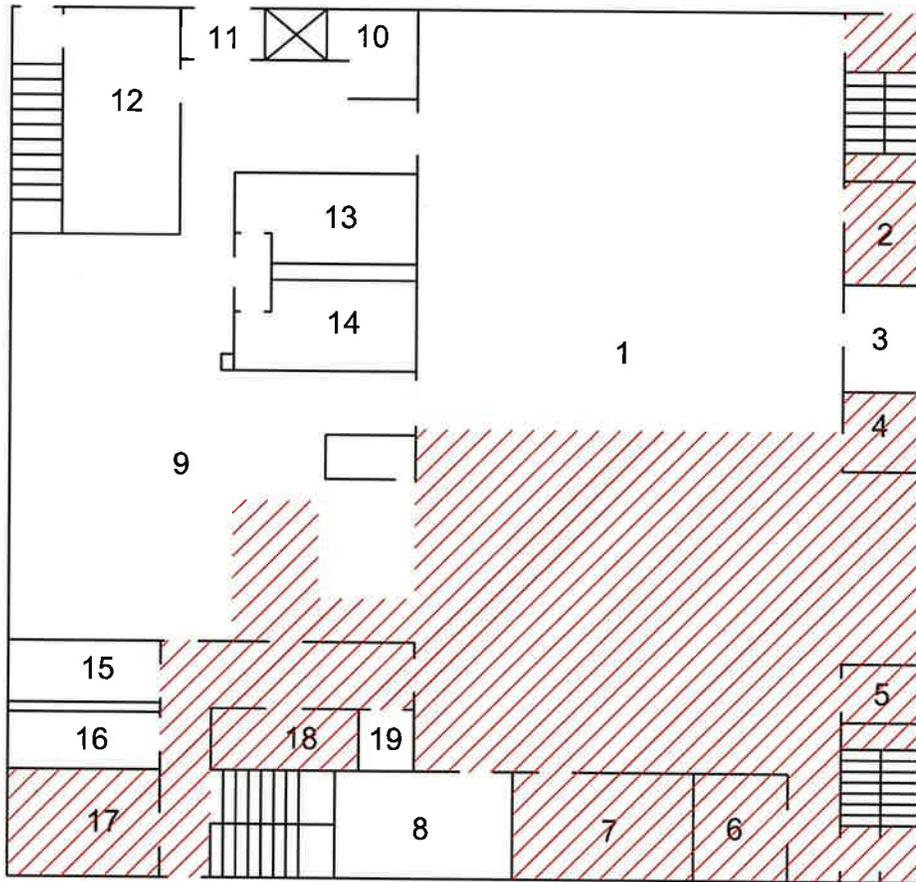
DIAGRAM #5  
ASBESTOS FLOORING LOCATIONS

UPPER LEVEL

-ASBESTOS FLOOR TILE AND MASTIC

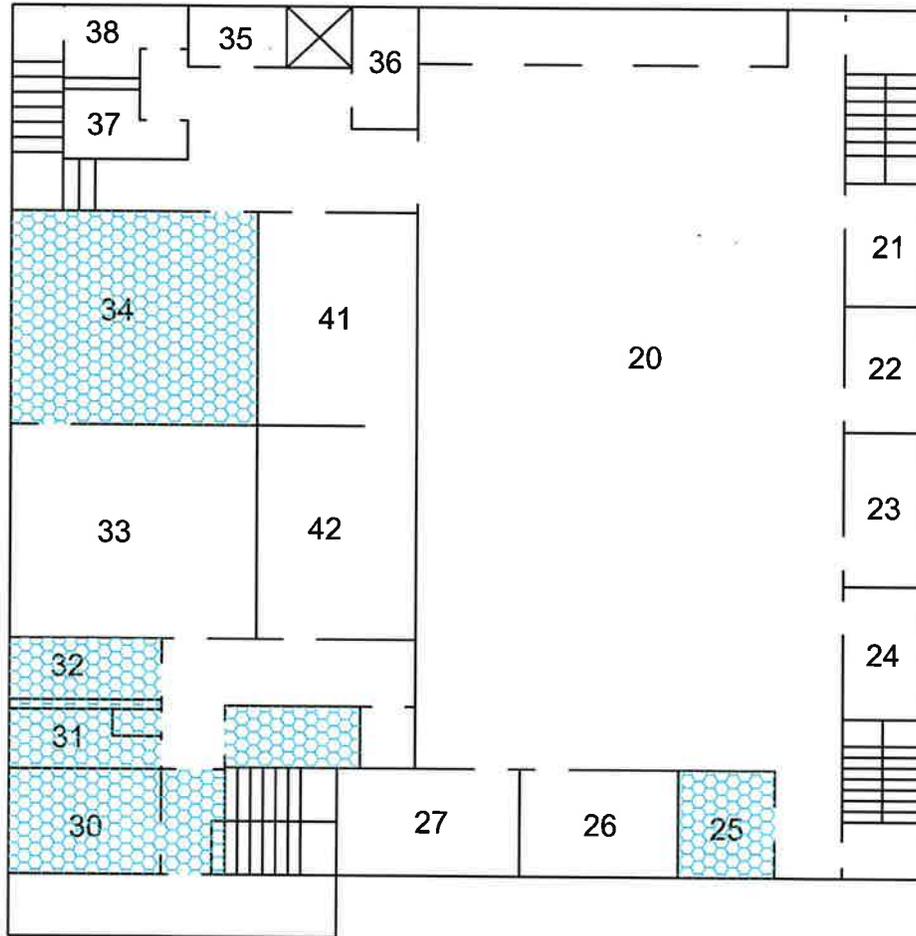
DIAGRAM #6  
ASBESTOS MISCELLANEOUS MATERIAL LOCATIONS

The lay-in ceiling panels common to several rooms and the on the both levels were determined to contain asbestos. The lay-in panels are considered friable asbestos materials.

LOWER LEVEL

-ASBESTOS CEILING PANELS

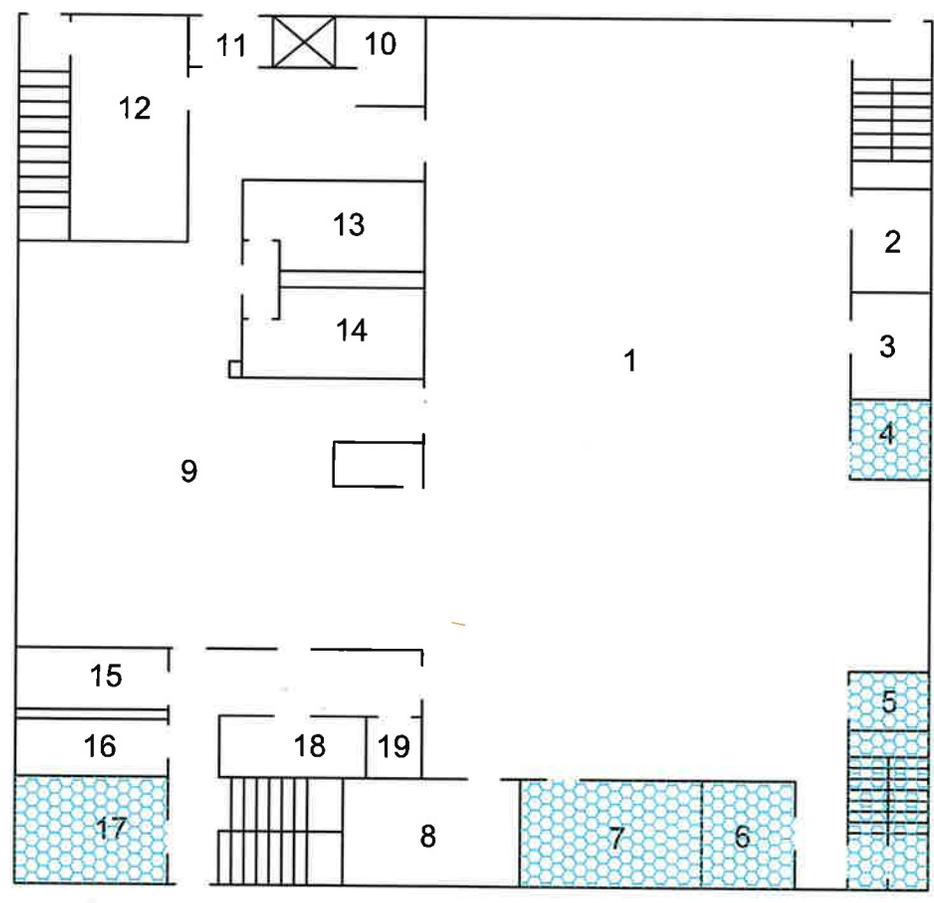
DIAGRAM #7  
ASBESTOS LAY-IN CEILING PANEL LOCATIONS

UPPER LEVEL

-ASBESTOS CEILING PANELS

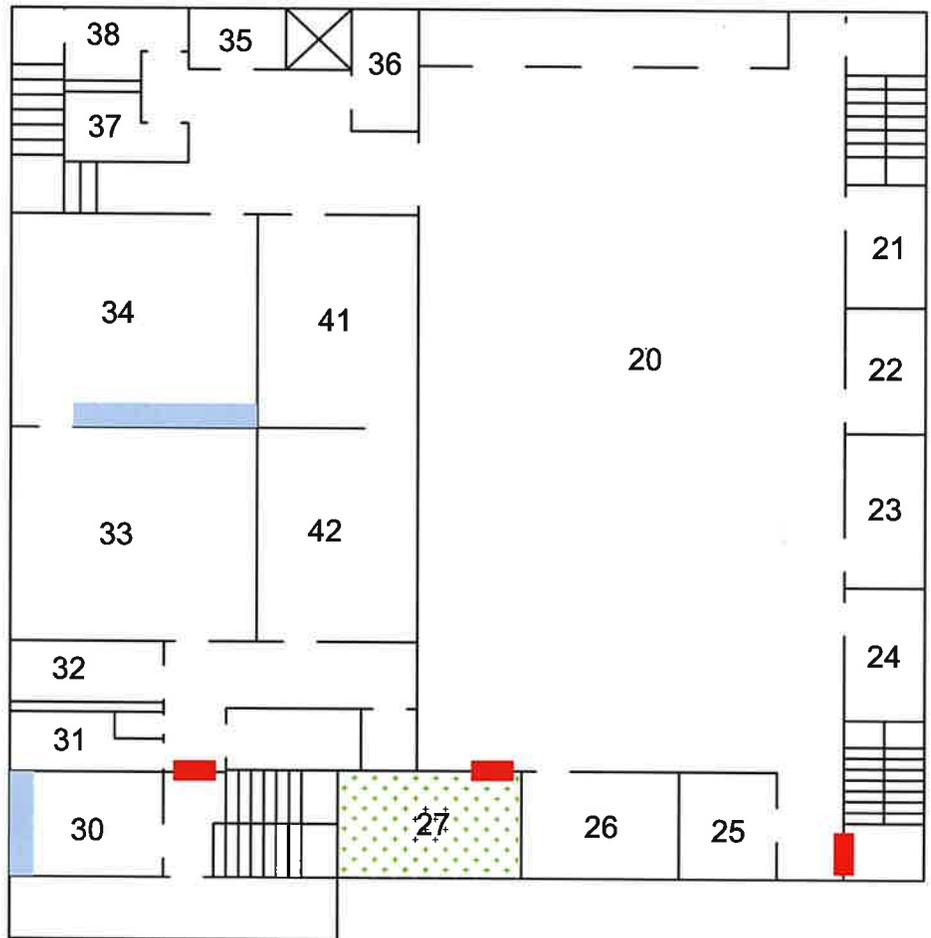
DIAGRAM #8  
ASBESTOS MISCELLANEOUS MATERIAL LOCATIONS

The foam insulation adhesive common to a wall in the lower level Room 30 and cabinets in Room 34 was determined to contain asbestos. The adhesives in their current condition are considered a non-friable asbestos material however could become friable during removal and/or demolition.

The vibration dampening cloths (white fabric type) located in the lower level mechanical room 27 were determined to contain asbestos. LEGEND observed six joints with the asbestos cloths. The clothes are considered friable asbestos materials.

LOWER LEVEL

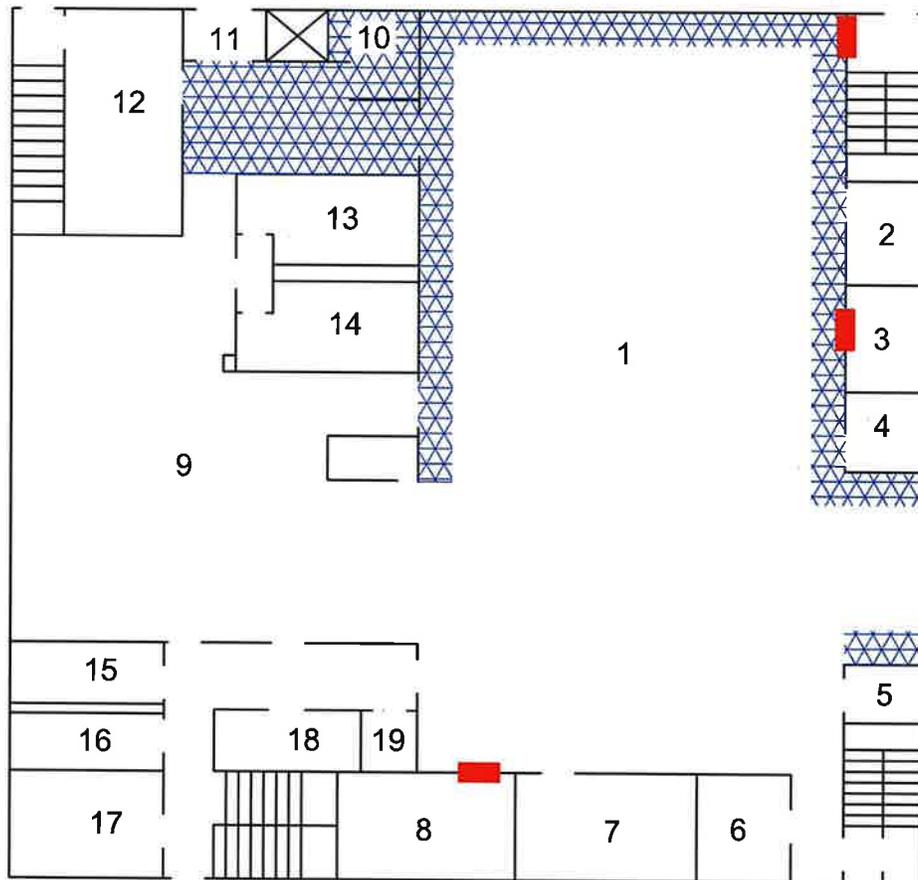
DIAGRAM #9  
ASBESTOS MISCELLANEOUS MATERIAL LOCATIONS

The black, wood wall panel adhesives were determined to contain asbestos. The adhesives were only present on the upper level. The adhesives in their current condition are considered a non-friable asbestos material however could become friable during removal and/or demolition.

The fire door core insulation found inside several fires doors was determined to contain asbestos. The insulation is considered a friable asbestos material

-ASBESTOS FIRE DOOR

UPPER LEVEL

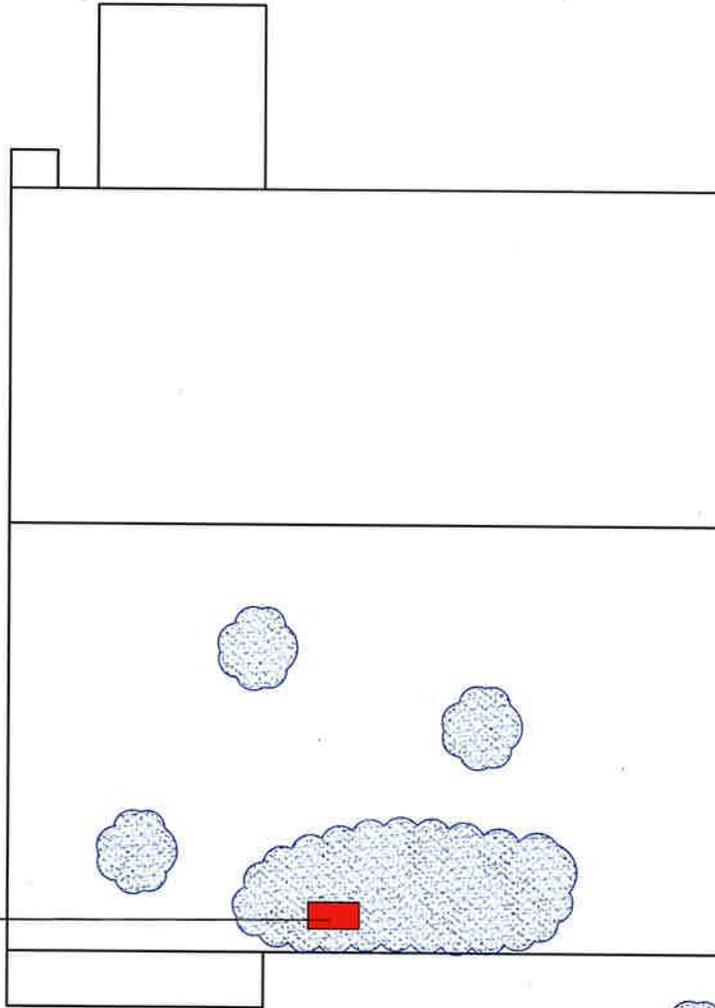
DIAGRAM #10  
ASBESTOS ROOFING MATERIAL LOCATIONS

The tar that is present on the top of the chimney (roof level) was determined to contain asbestos. The tar in its current condition is considered a non-friable asbestos material.

The tar found around select HVAC mechanical penetrations at the roof level was determined to contain asbestos (on the flashing/curbs). The tar in its current condition is considered a non-friable asbestos material. Note that some of the tar may be covered by the existing rubber roof membrane.

ASBESTOS TAR ON TOP OF CHIMNEY

ROOF LEVEL
