**PHASE I  
ENVIRONMENTAL SITE ASSESSMENT**

Myth Nightclub Property  
3090 Southlawn Drive  
Maplewood, Minnesota 55109

**AET Project No. P-0013925**

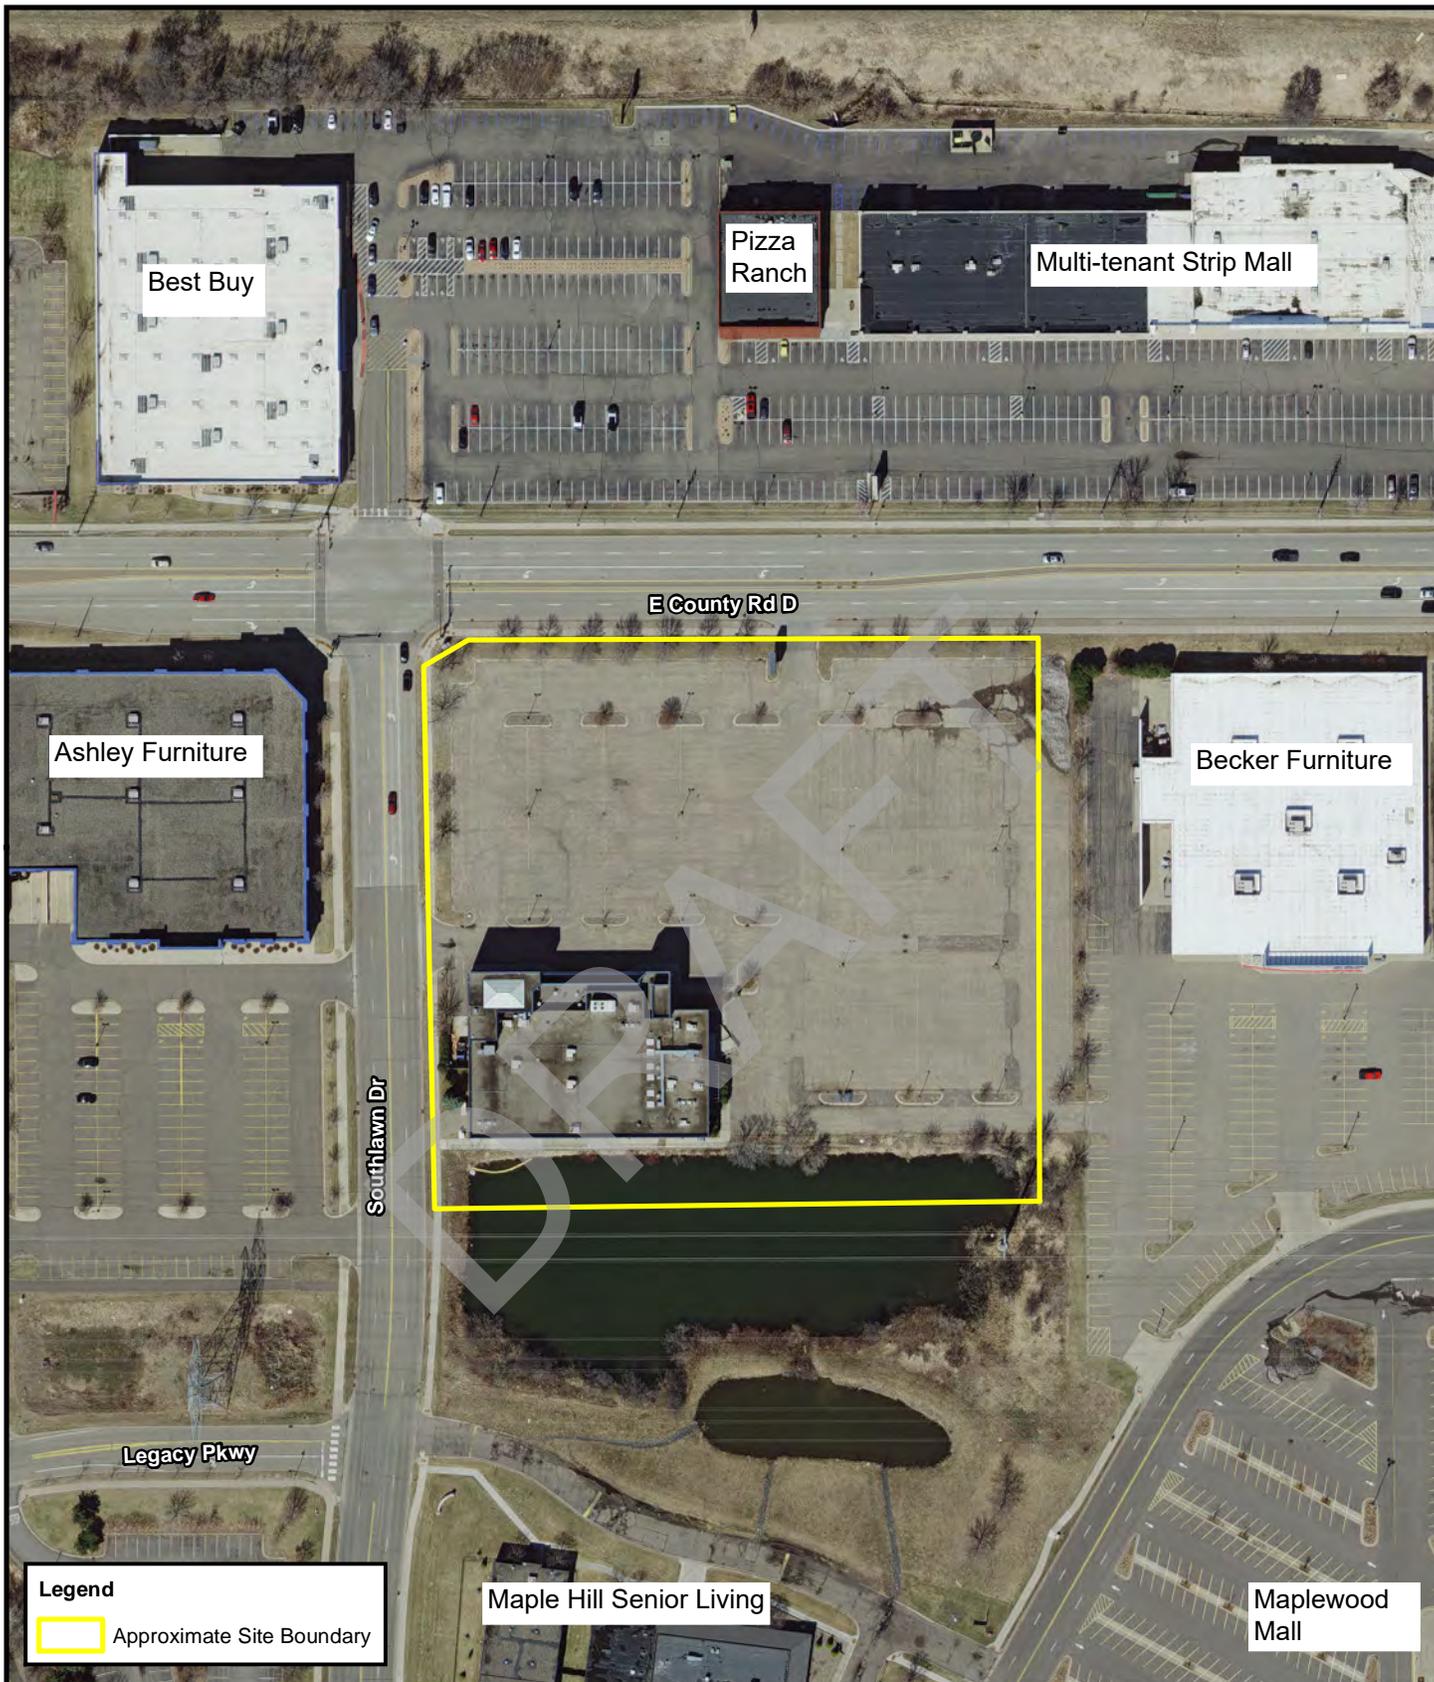
Figure 1 shows the location of the Subject Property and Figure 2 shows the configuration of the Subject Property. Information obtained from the Ramsey County property information website used to identify the Subject Property is included in Appendix B.
