CENTURY PONDS

ENVIRONMENTAL ASSESSMENT WORKSHEET (EAW)

CITY: MAPLEWOOD

June 2025

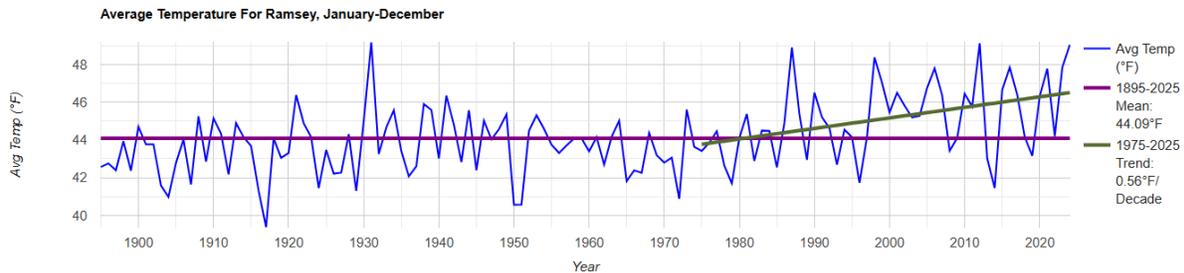
Average annual temperature for the entire reporting period was 44.09 °F and the average for the 21st Century, 2000-2025 was 45.3 °F. The trend for the past 50 years is an increase of 0.56 °F per decade. See Figure 1 below.

Figure 1. Historic Annual Average Temperature for Ramsey County (1895-2025)

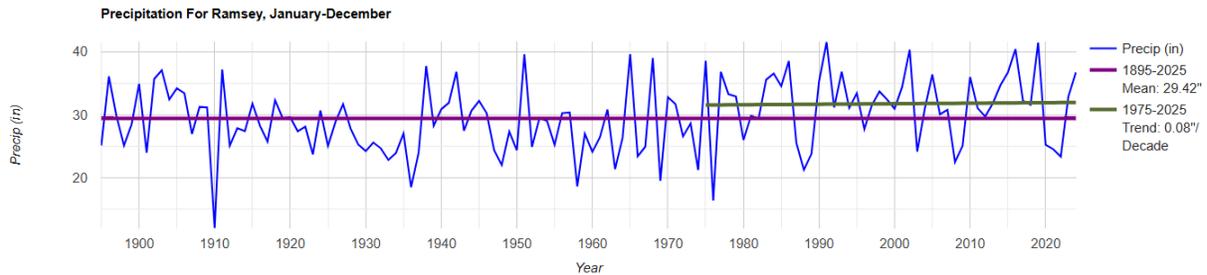
Total annual precipitation for the entire reporting period averaged 29.42 inches, and the average for the 21st Century was 30.53 inches. The trend for the past 50 years is an increase of 0.08 inches per decade. See Figure 2 below.

Figure 2. Historic Annual Average Precipitation for Ramsey County (1895-2025)

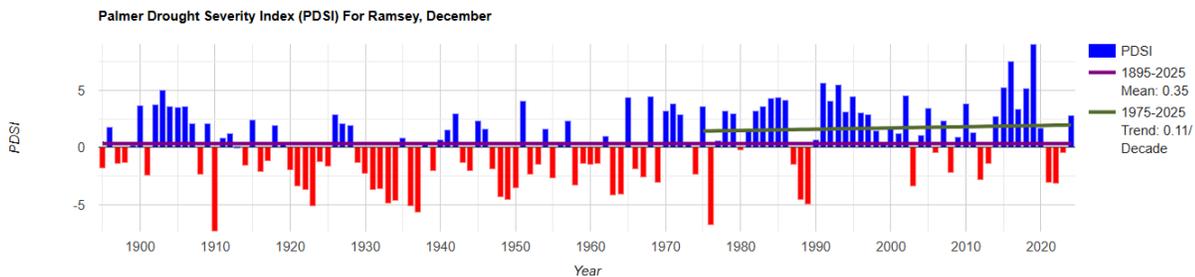
The average PDSI for the entire reporting period was 0.35, and the average for the 21st Century was 1.67. The trend for the past 50 years is an increase of 0.11 per decade. See Figure 3 below.

Figure 3. Historic PDSI Values for Ramsey County (1895-2025)

These three parameters, average annual temperature, total annual precipitation, and PDSI, show general trends consistent with climate change predictions for eastern Minnesota: warmer temperatures, less precipitation, and more variable and extreme conditions, such as higher maximum temperature and more variable precipitation that could lead to more drought periods. With an increase in more variable and extreme conditions, it is expected that more precipitation will be delivered in both large quantities in intense storm events, accompanied with periods of long drought conditions. This has the effect of creating more flood events, increased runoff, and potentially, less infiltration of precipitation into the groundwater. Higher temperatures will result in more evapotranspiration, and when combined with more variable precipitation, and will lead to more intense droughts.

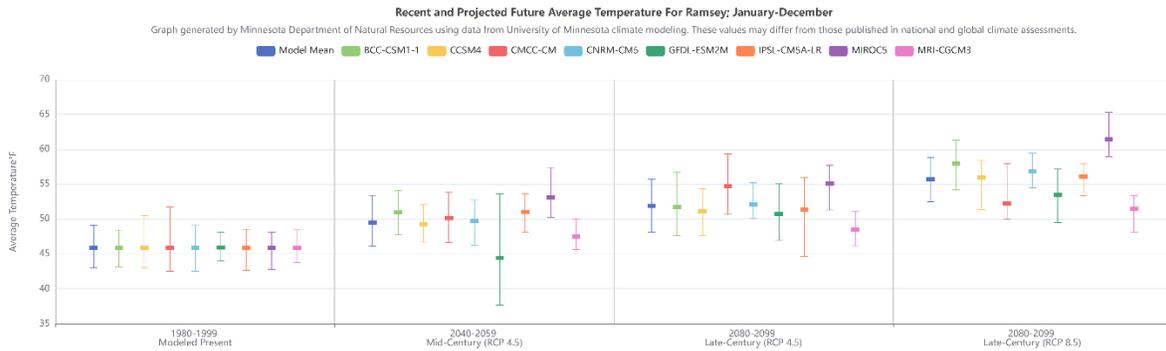
The RCP values are defined as Relative Concentration Pathways (RCP) of 4.5 watts/m² or 8.5 watts/m² of energy through radiative forcing per unit land area. These values roughly correspond to carbon dioxide (CO₂) concentrations of 650 ppm or 1,000 ppm (lower or higher emissions scenarios). Current atmospheric CO₂ concentration is around 410 ppm. Projections for future average annual temperature and total annual precipitation are shown in Figures 4 and 5 below.

Figure 4. Project Temperatures in Ramsey County

The projected changes from these models are fairly consistent with that described above from the MN DNR Minnesota Climate Explorer. In particular, these models predict higher average temperatures, an increase in extreme heat, and slightly higher precipitation than was observed historically. The largest increases occur later in the 21st Century and under higher emission scenarios. The models also predict increased severity of large storm events. Both tools show a slight increase in precipitation. This is likely due to an increase in climate variability. Overall, precipitation may not significantly increase, but the likelihood of extreme weather is likely. It is assumed that more extreme storms will occur, followed by longer periods of drought conditions.

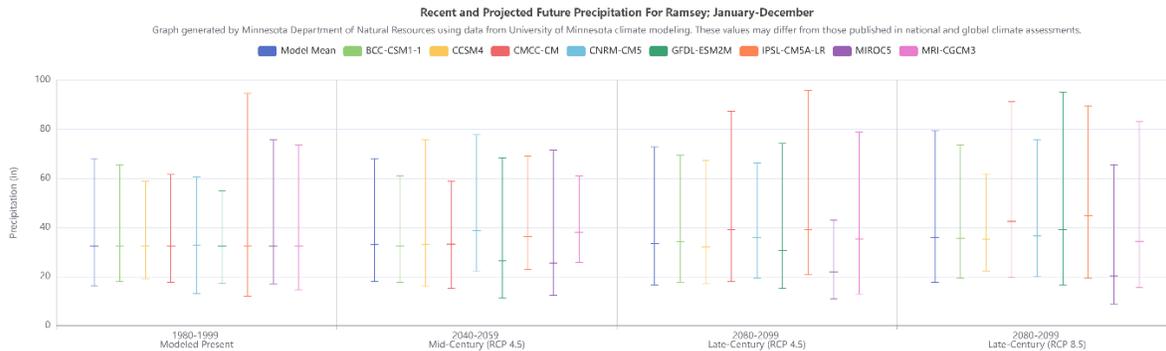
Figure 5. Projected Precipitation in Ramsey County

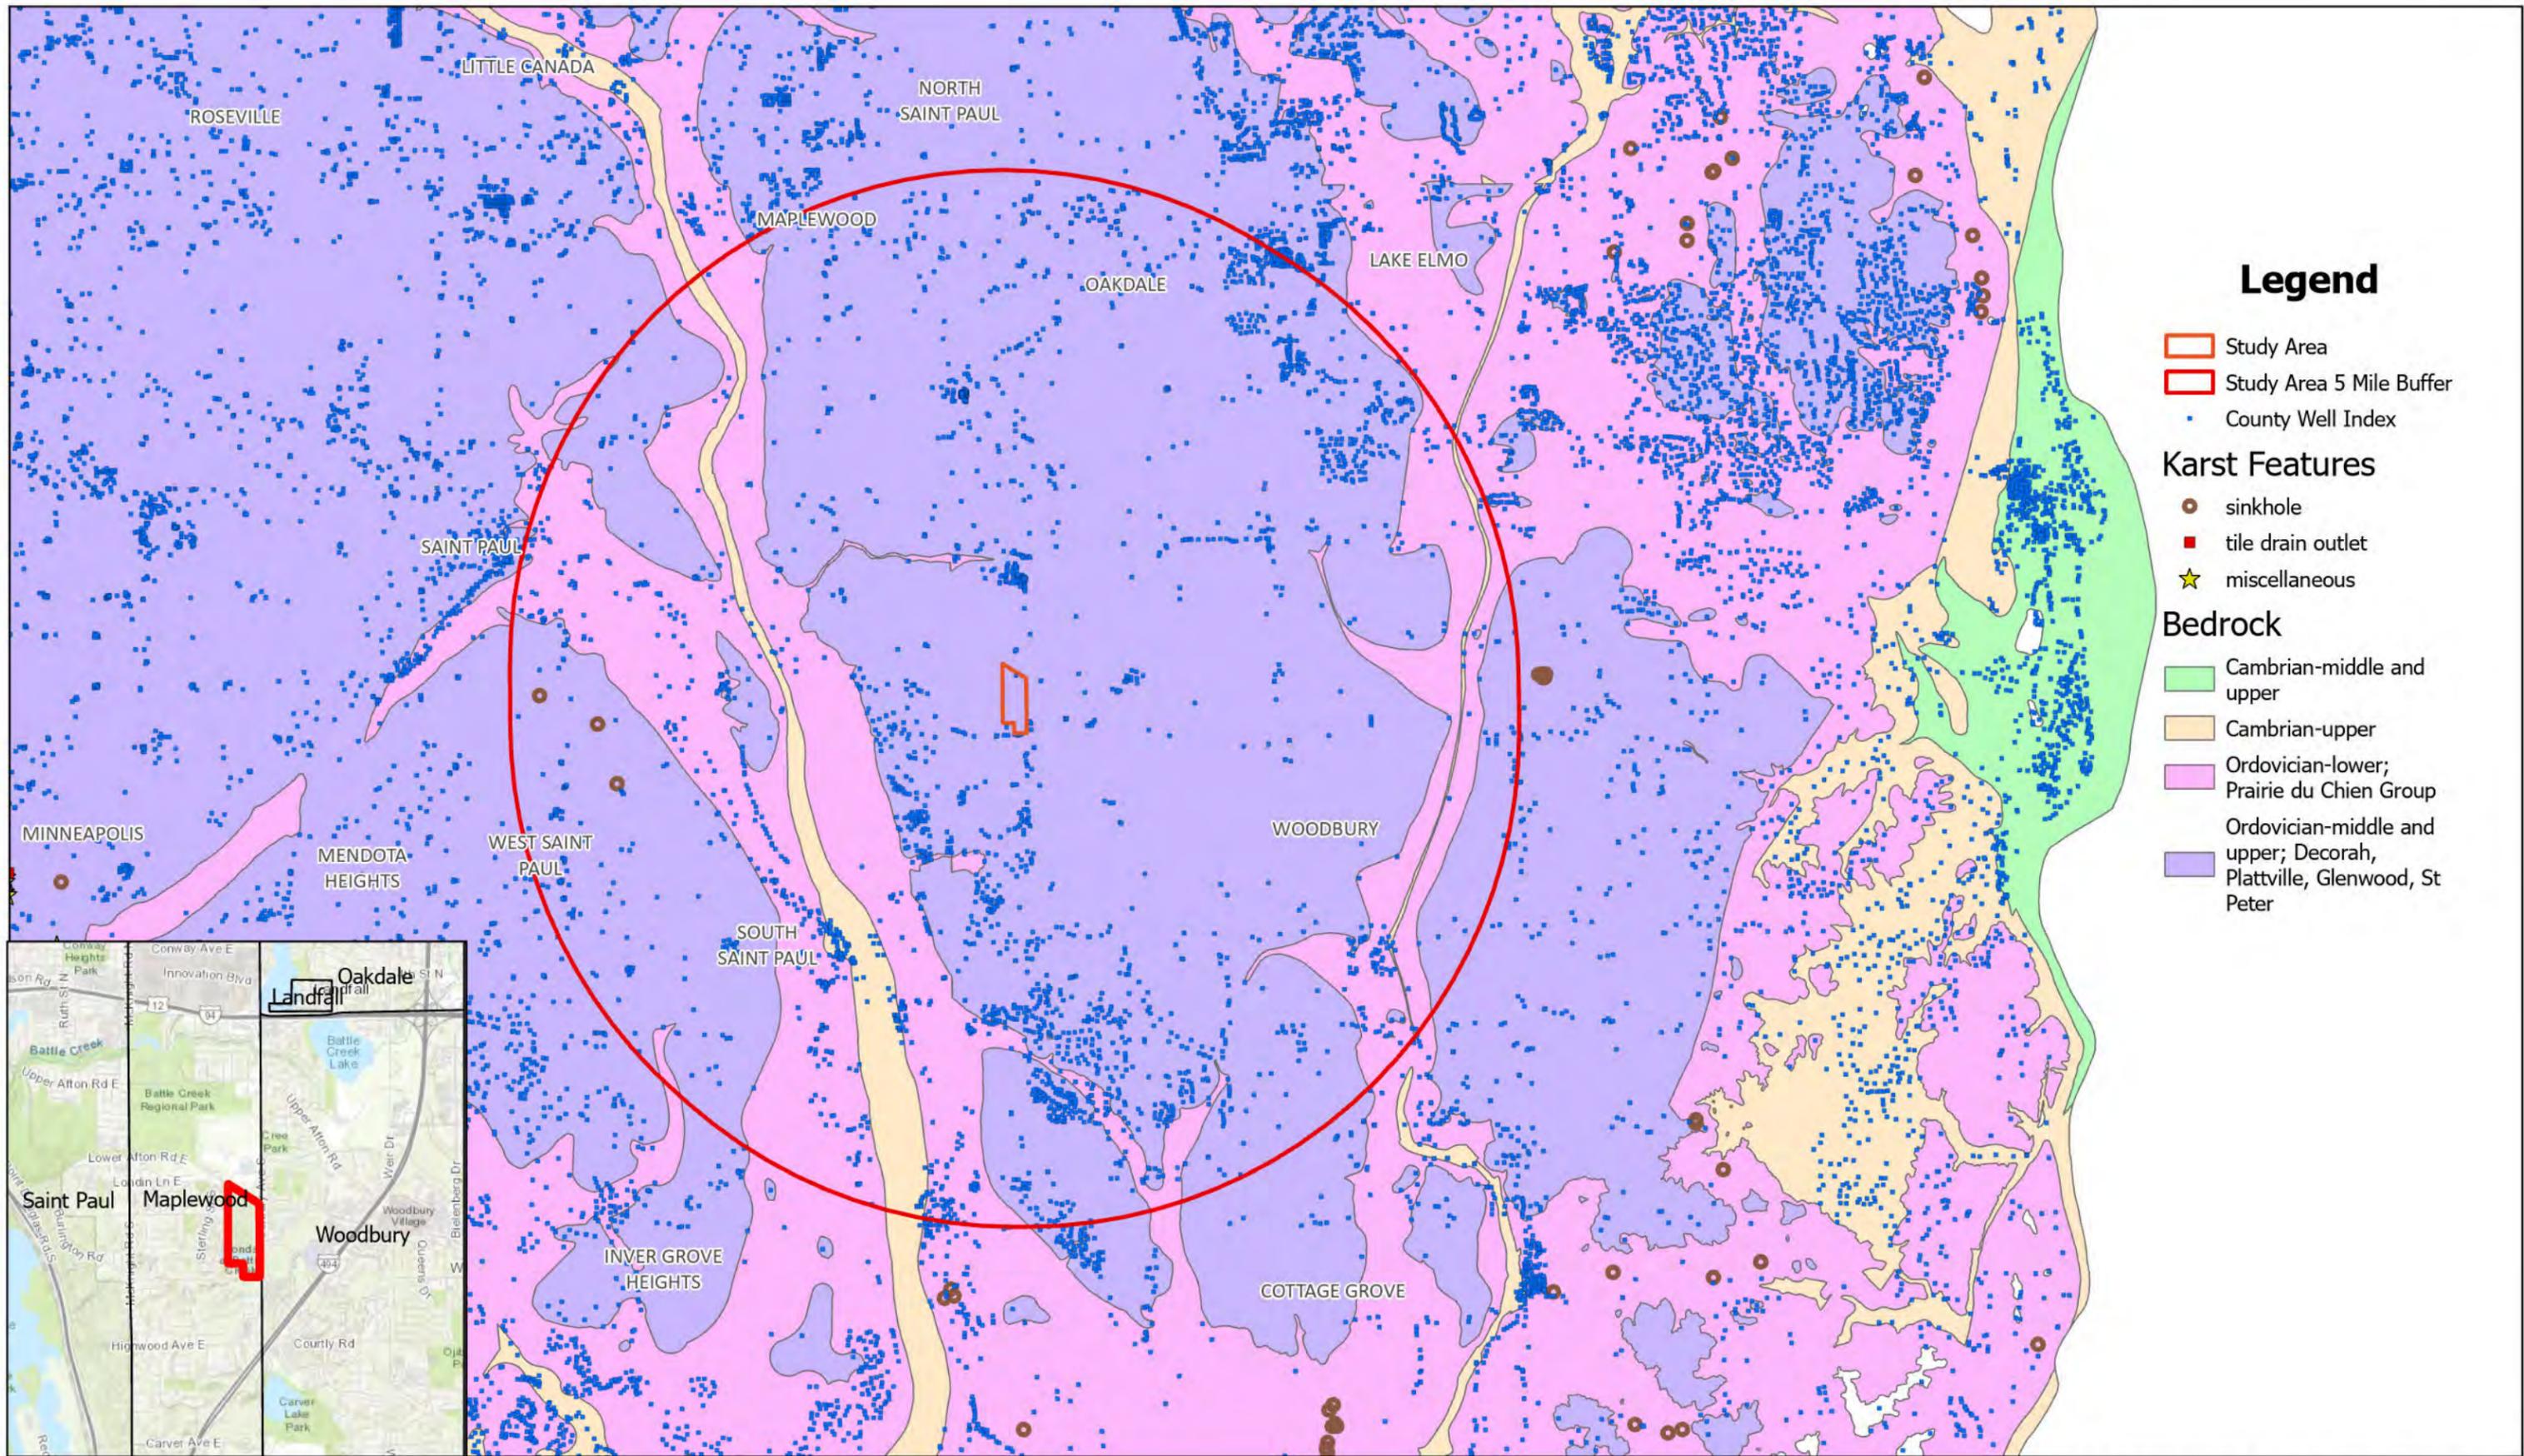
**Figure 8. Geology and County Well Index
Maplewood, Ramsey County, MN**

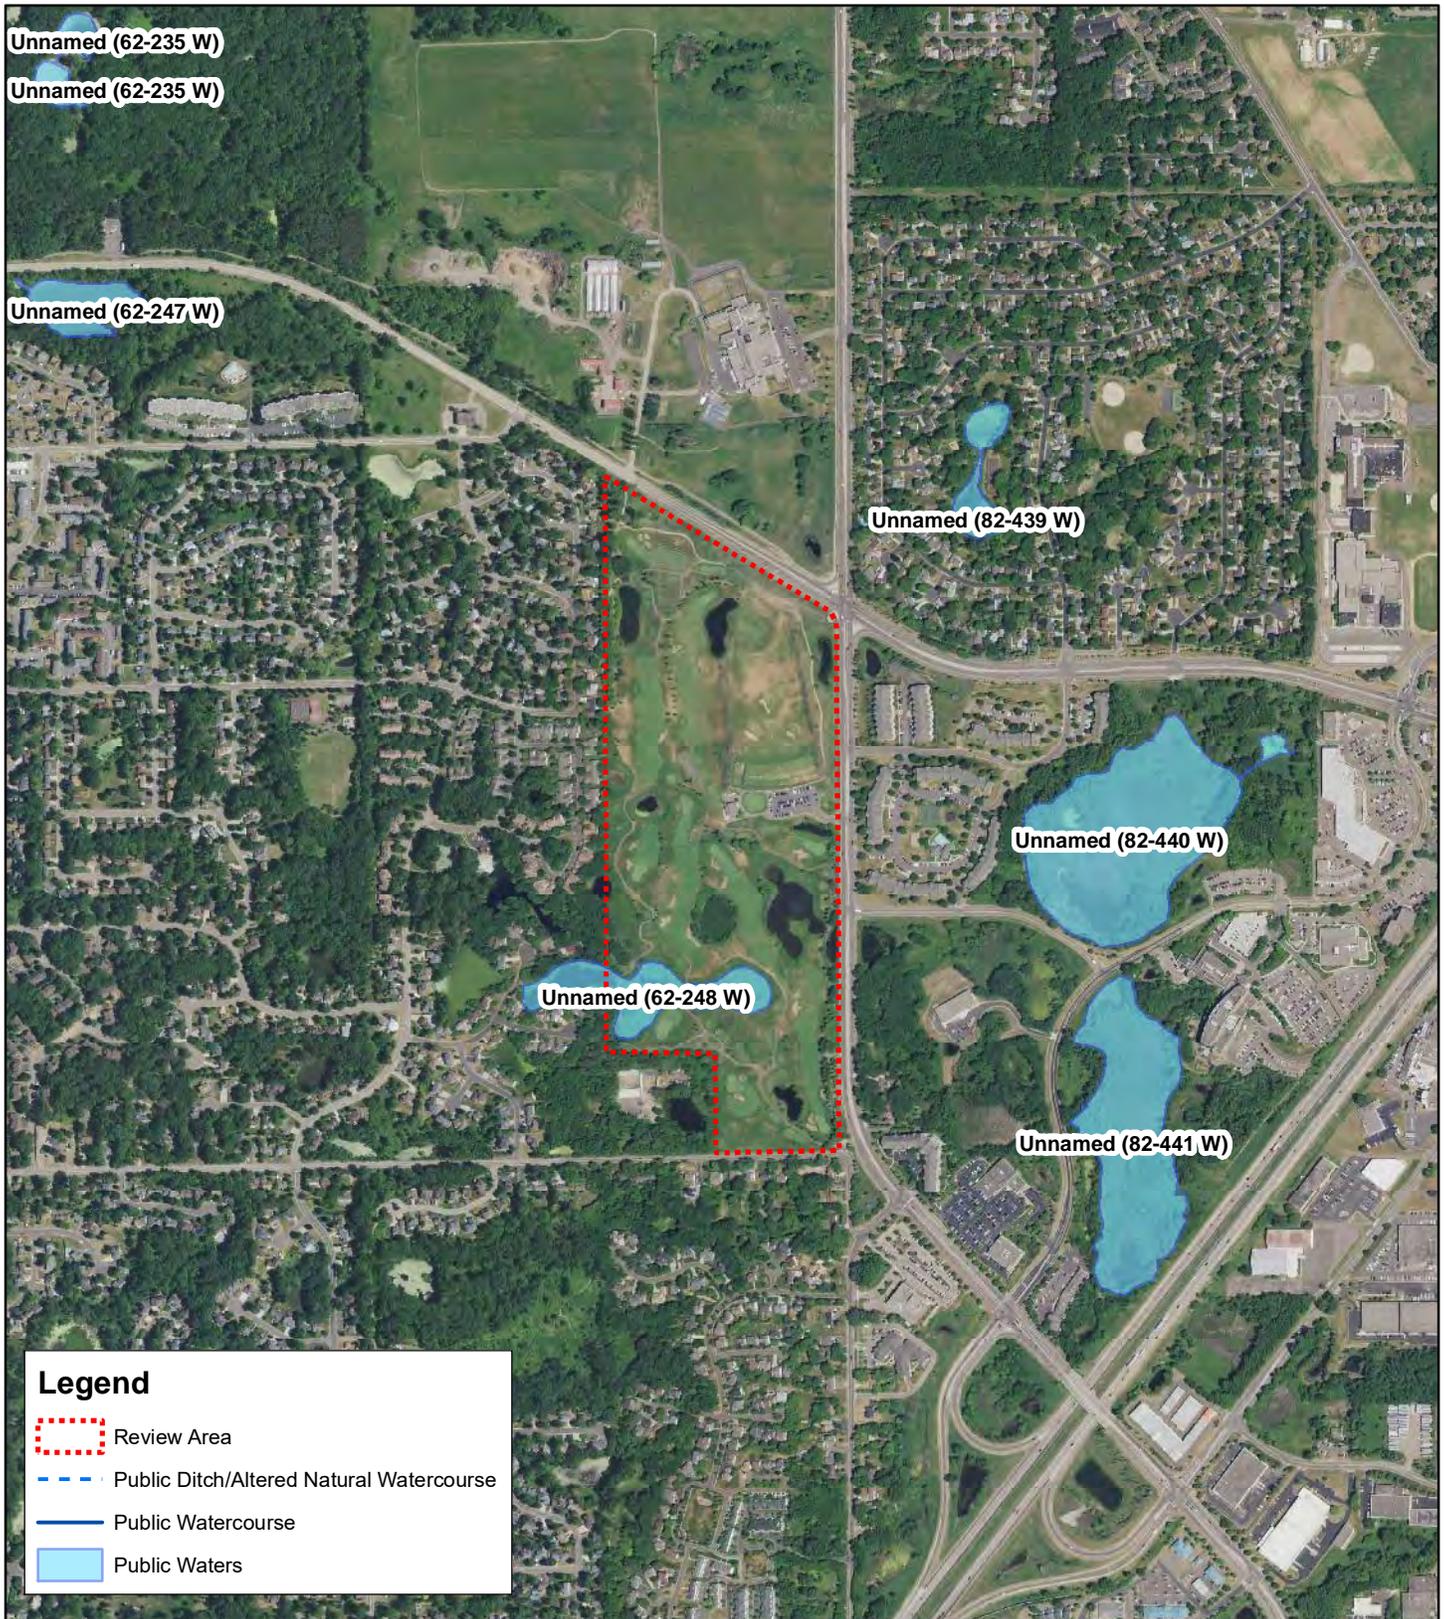
Figure 5 - DNR Public Waters Inventory

The Minnesota DNR Public Waters Inventory (Minnesota Department of Natural Resources 2015) identified DNR Public Water Wetland 62-248 W (unnamed) within the review area, two unnamed DNR Public Water Wetlands (62-439 W and 82-440 W) within 1,000 sf of the review area boundaries, and an unnamed DNR Public Water Wetland within 1,200 sf of the eastern review area boundary (**Figure 5**).

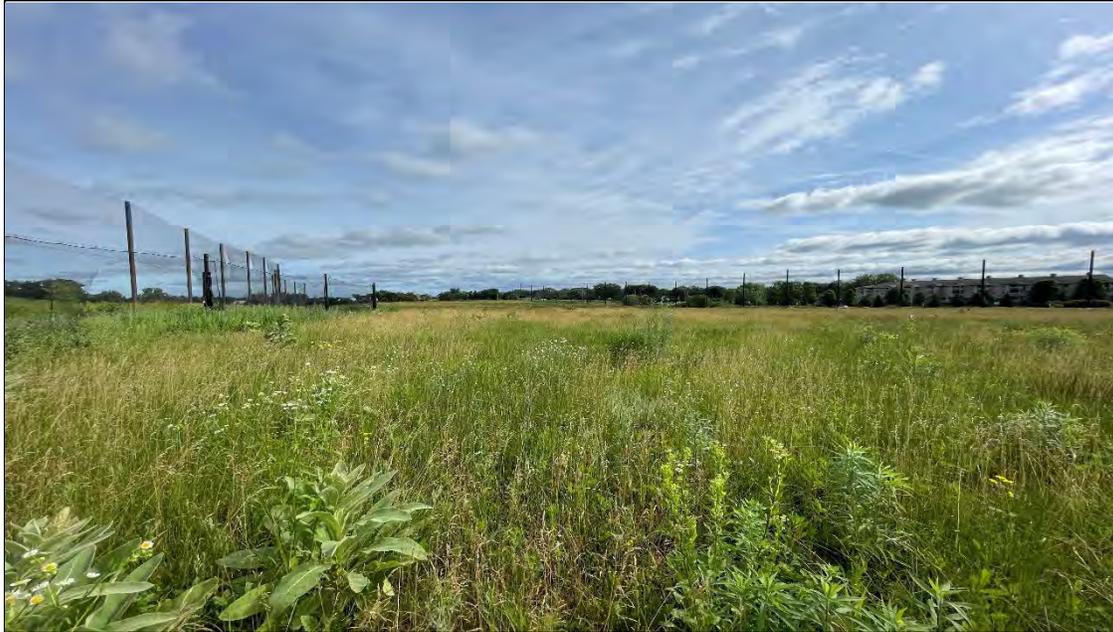
Photo 1. Old driving range facing north. This area is dominated by planted grass species.

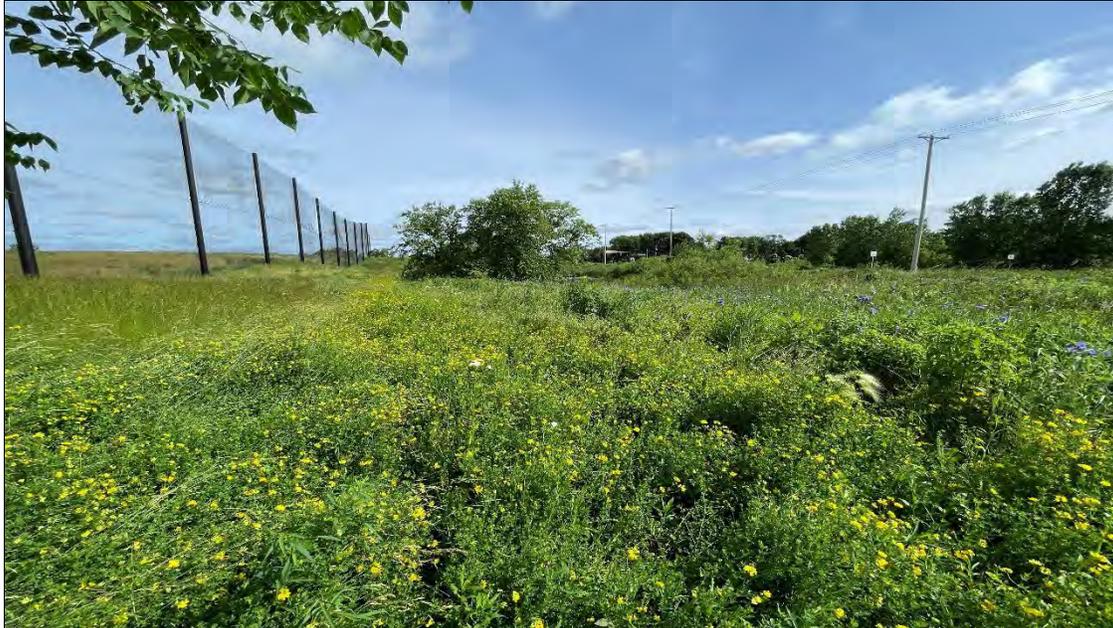
Photo 2. Area near Wetland 4 and drainageway 2. This area is dominated by non-native and native flowering plants. Photo taken facing north near drainageway 2.

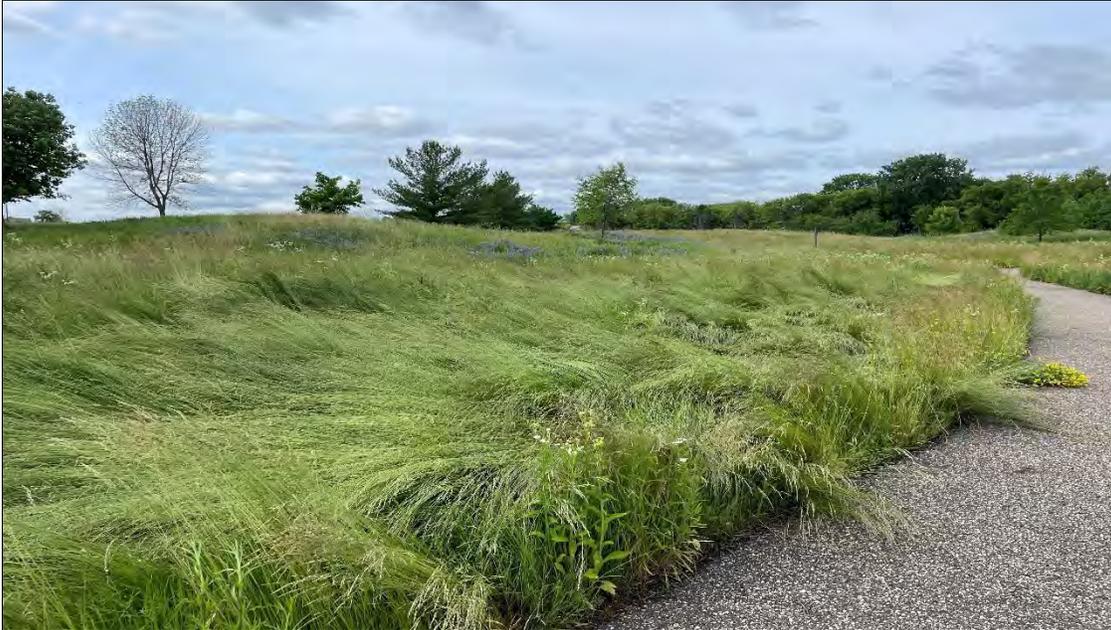
Photo 3. Photo represents the common planted grass species present adjacent to the path. Photo take in the northwestern part of the project facing southwest.

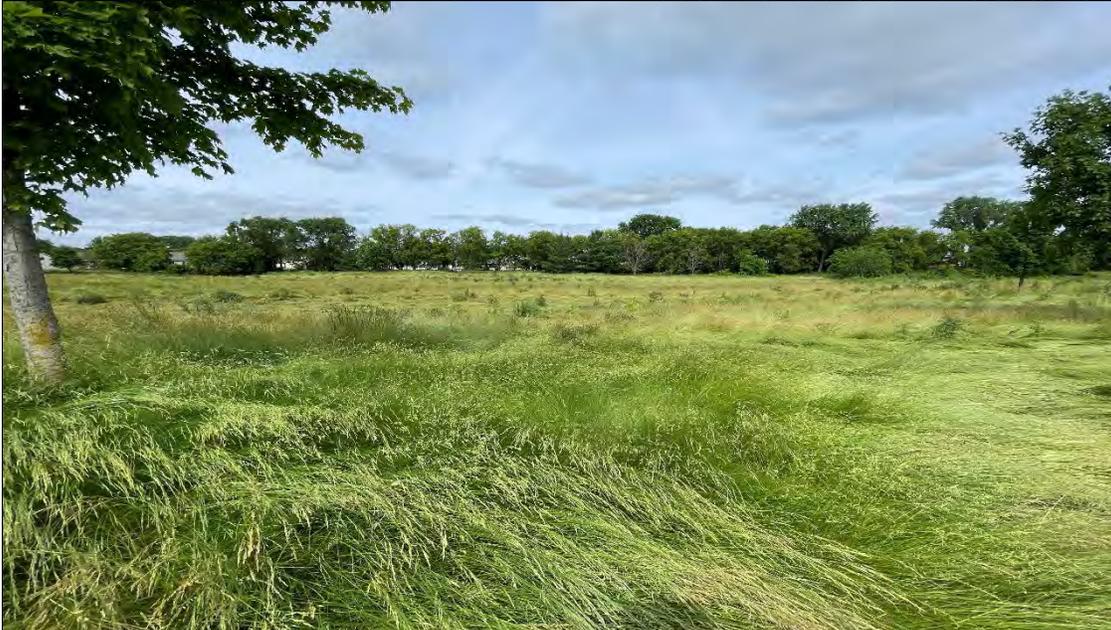
Photo 4. Typical grassland conditions throughout the fairways.

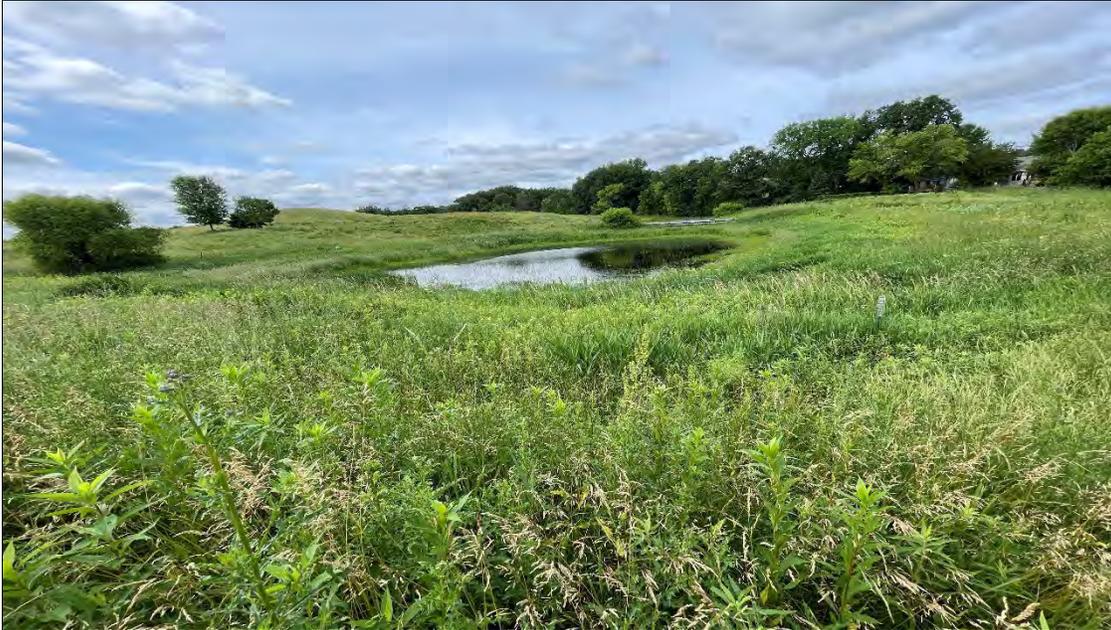
Photo 5. Some of the native and non-native flowering vegetation that surround some of the wetlands on site. Photo was taken facing west across Wetland 6.

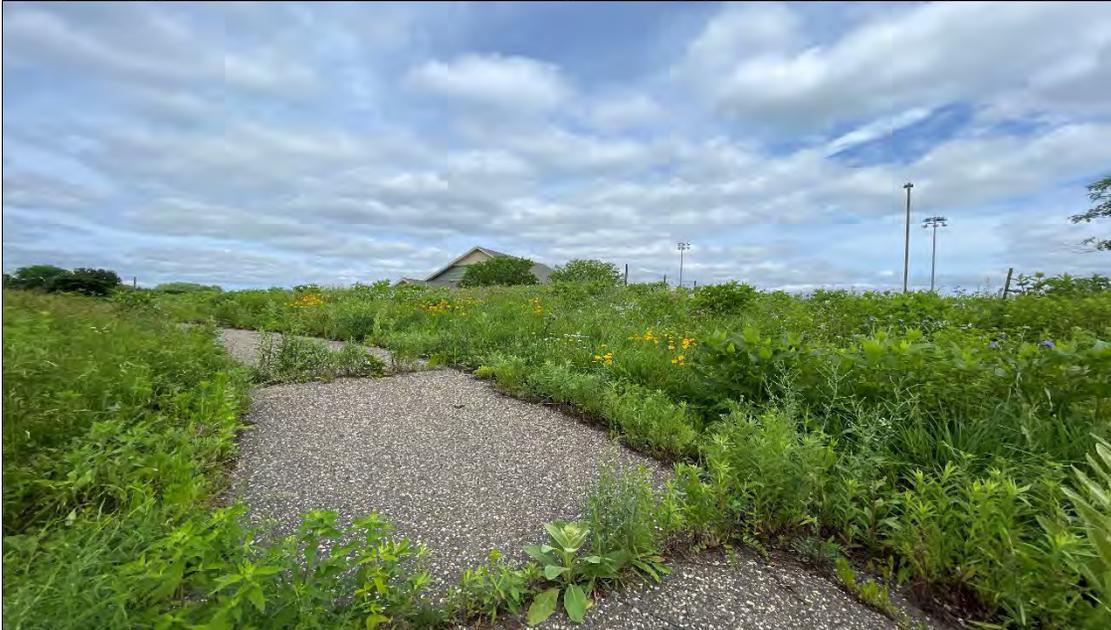
Photo 6. Areas of native and non-native flowering vegetation near the old clubhouse. Photo is taken south of the clubhouse facing northwest.

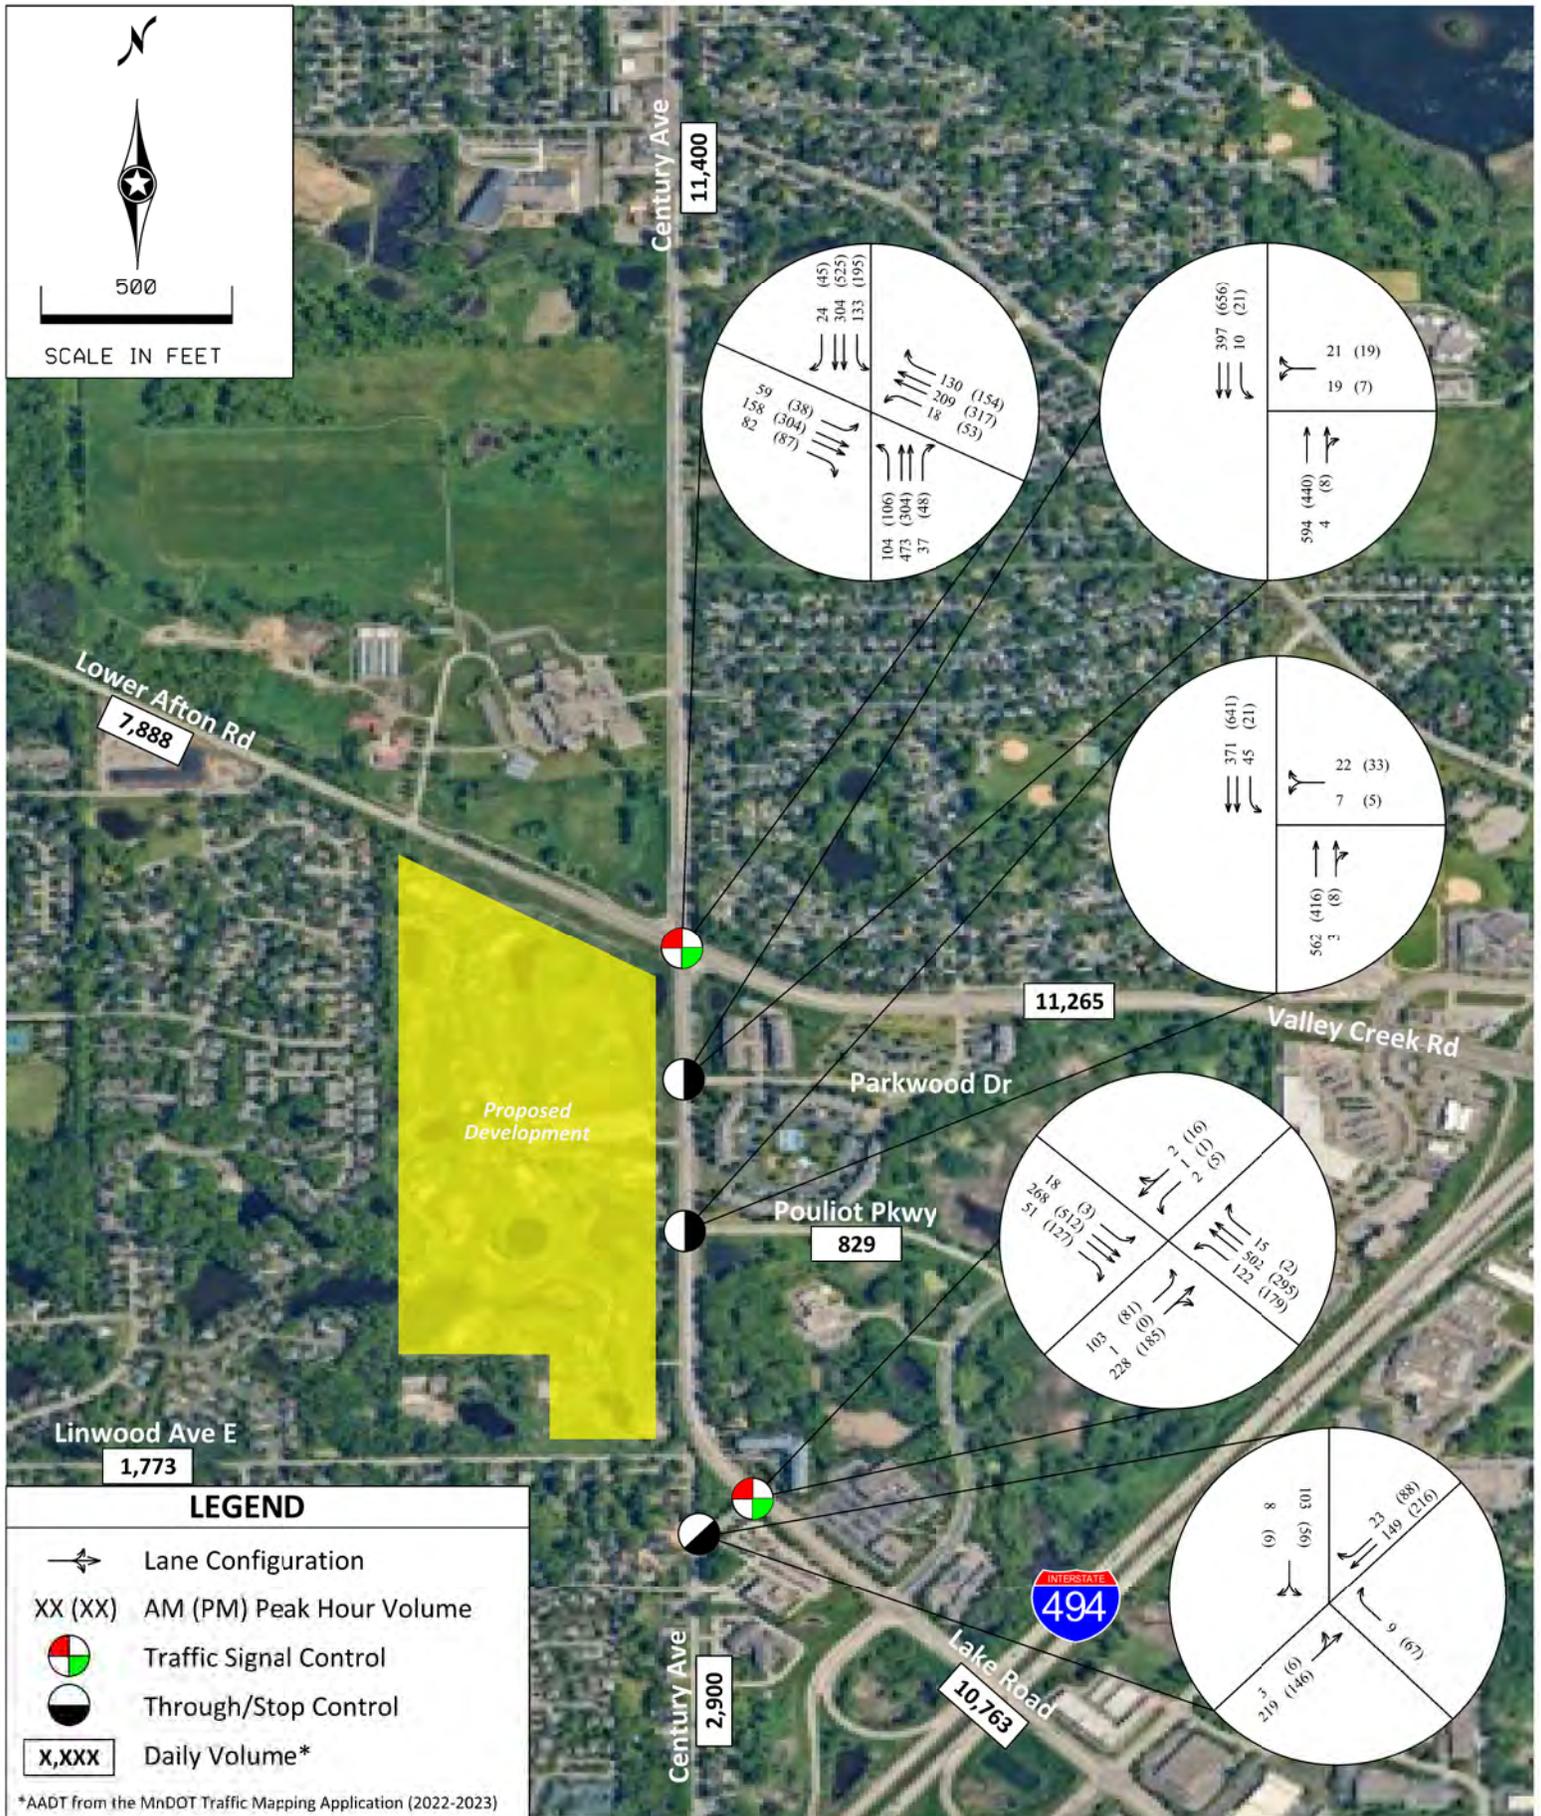
The peak hours were observed to be 7:15 to 8:15 AM and 4:30 to 5:30 PM during the data collection period. Existing traffic volumes are shown in **Figure 2**. Detailed intersection turning movement counts are included in **Appendix A**.

Figure 2
Existing Volumes

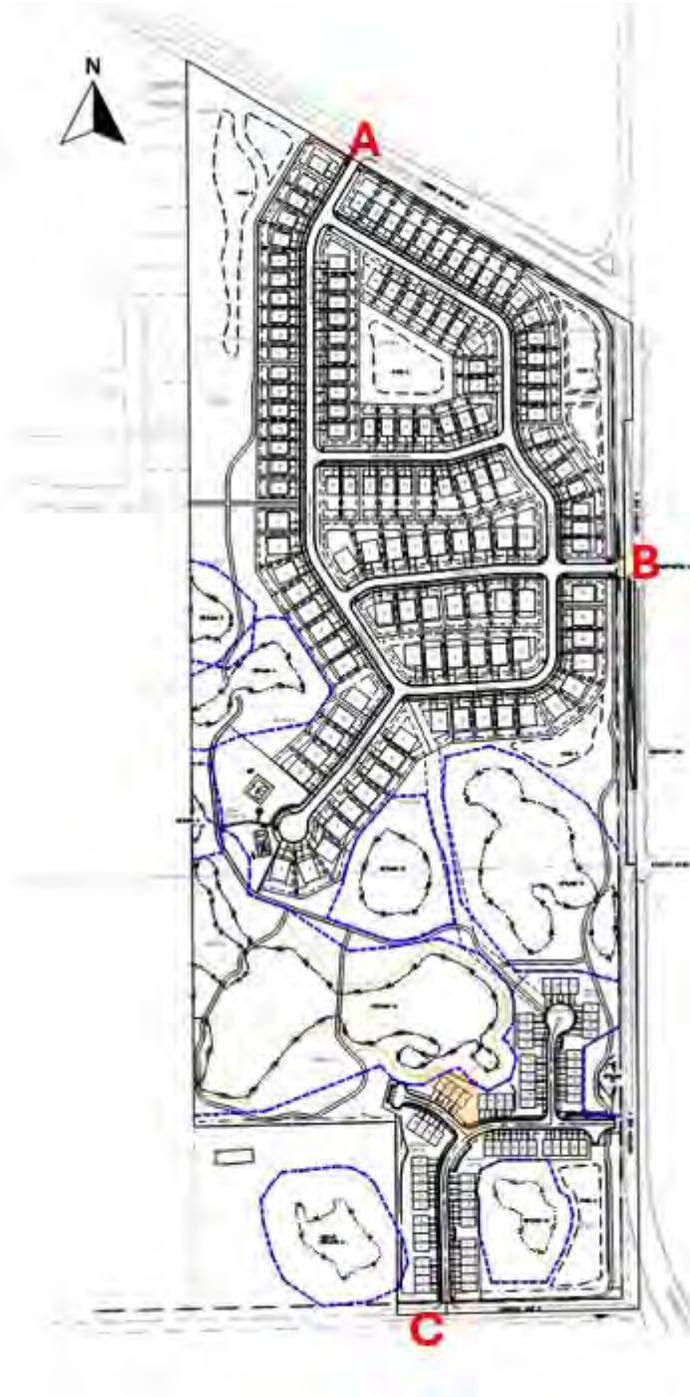
Within each portion of the development the proposed residences are connected via proposed roadways. The single-family properties will include 60-foot roadways which will be built to City standards yet remain private. The townhome properties will utilize a 40-foot private drive.

Figure 3. Proposed Site Plan

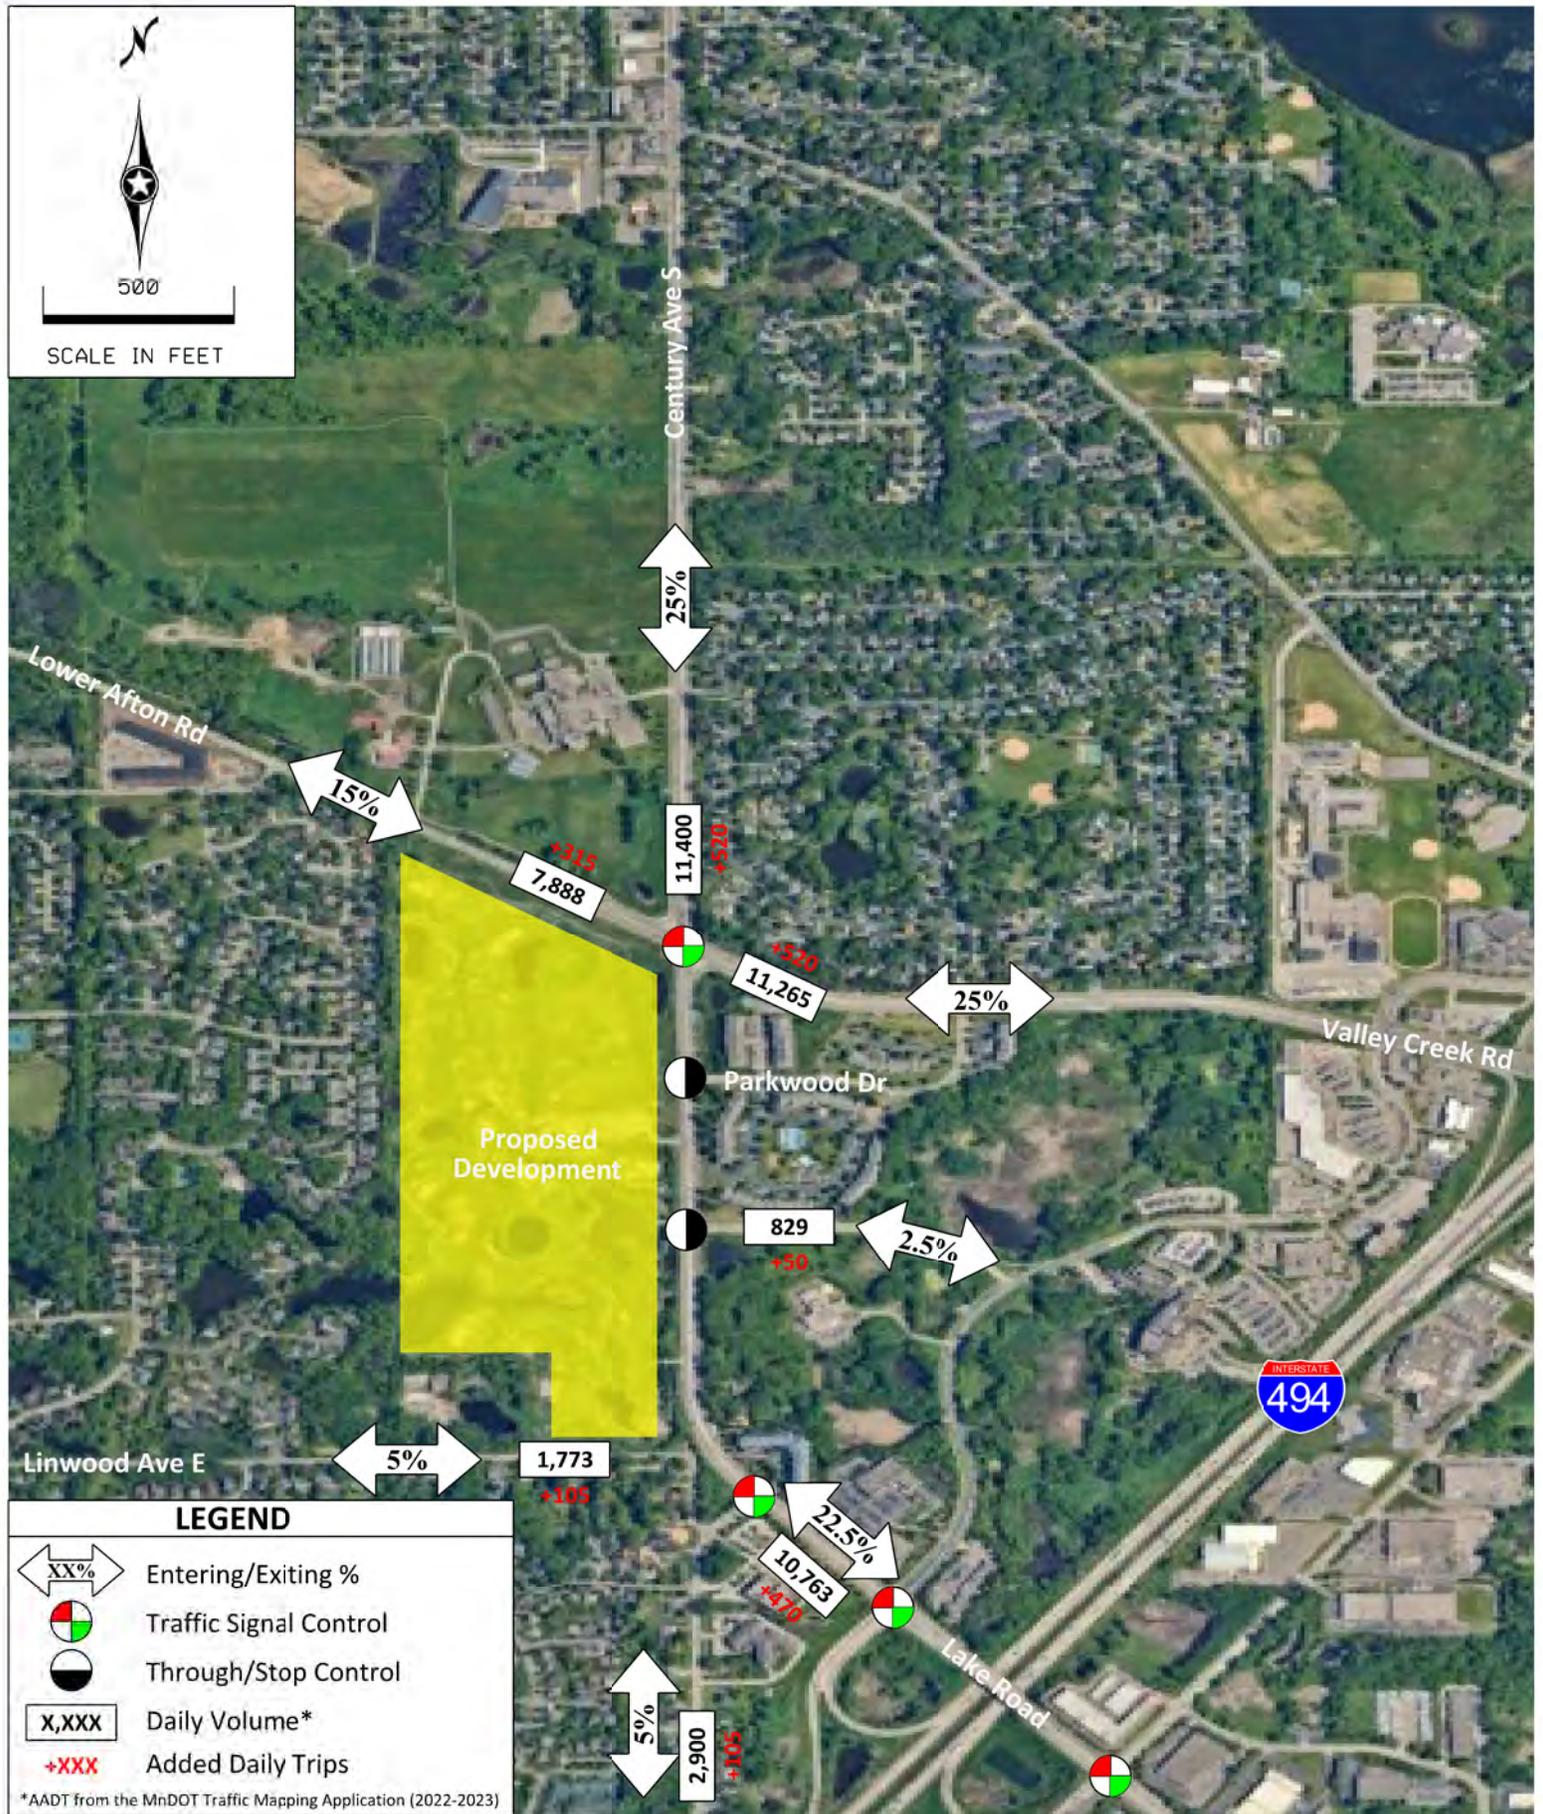
To understand impacts to the adjacent roadway network, AADTs documented in **Figure 4** and engineering judgment were utilized to develop a distribution of development trips. As noted, the single-family properties are provided access along Lower Afton Road (**A**) and Century Avenue (**B**) to the north and east, whereas the townhome properties have access along Linwood Avenue (**C**) to the south. Added peak hour trips for each of the study intersections are documented in **Figure 5**.

Figure 4
Proposed Trip Distribution

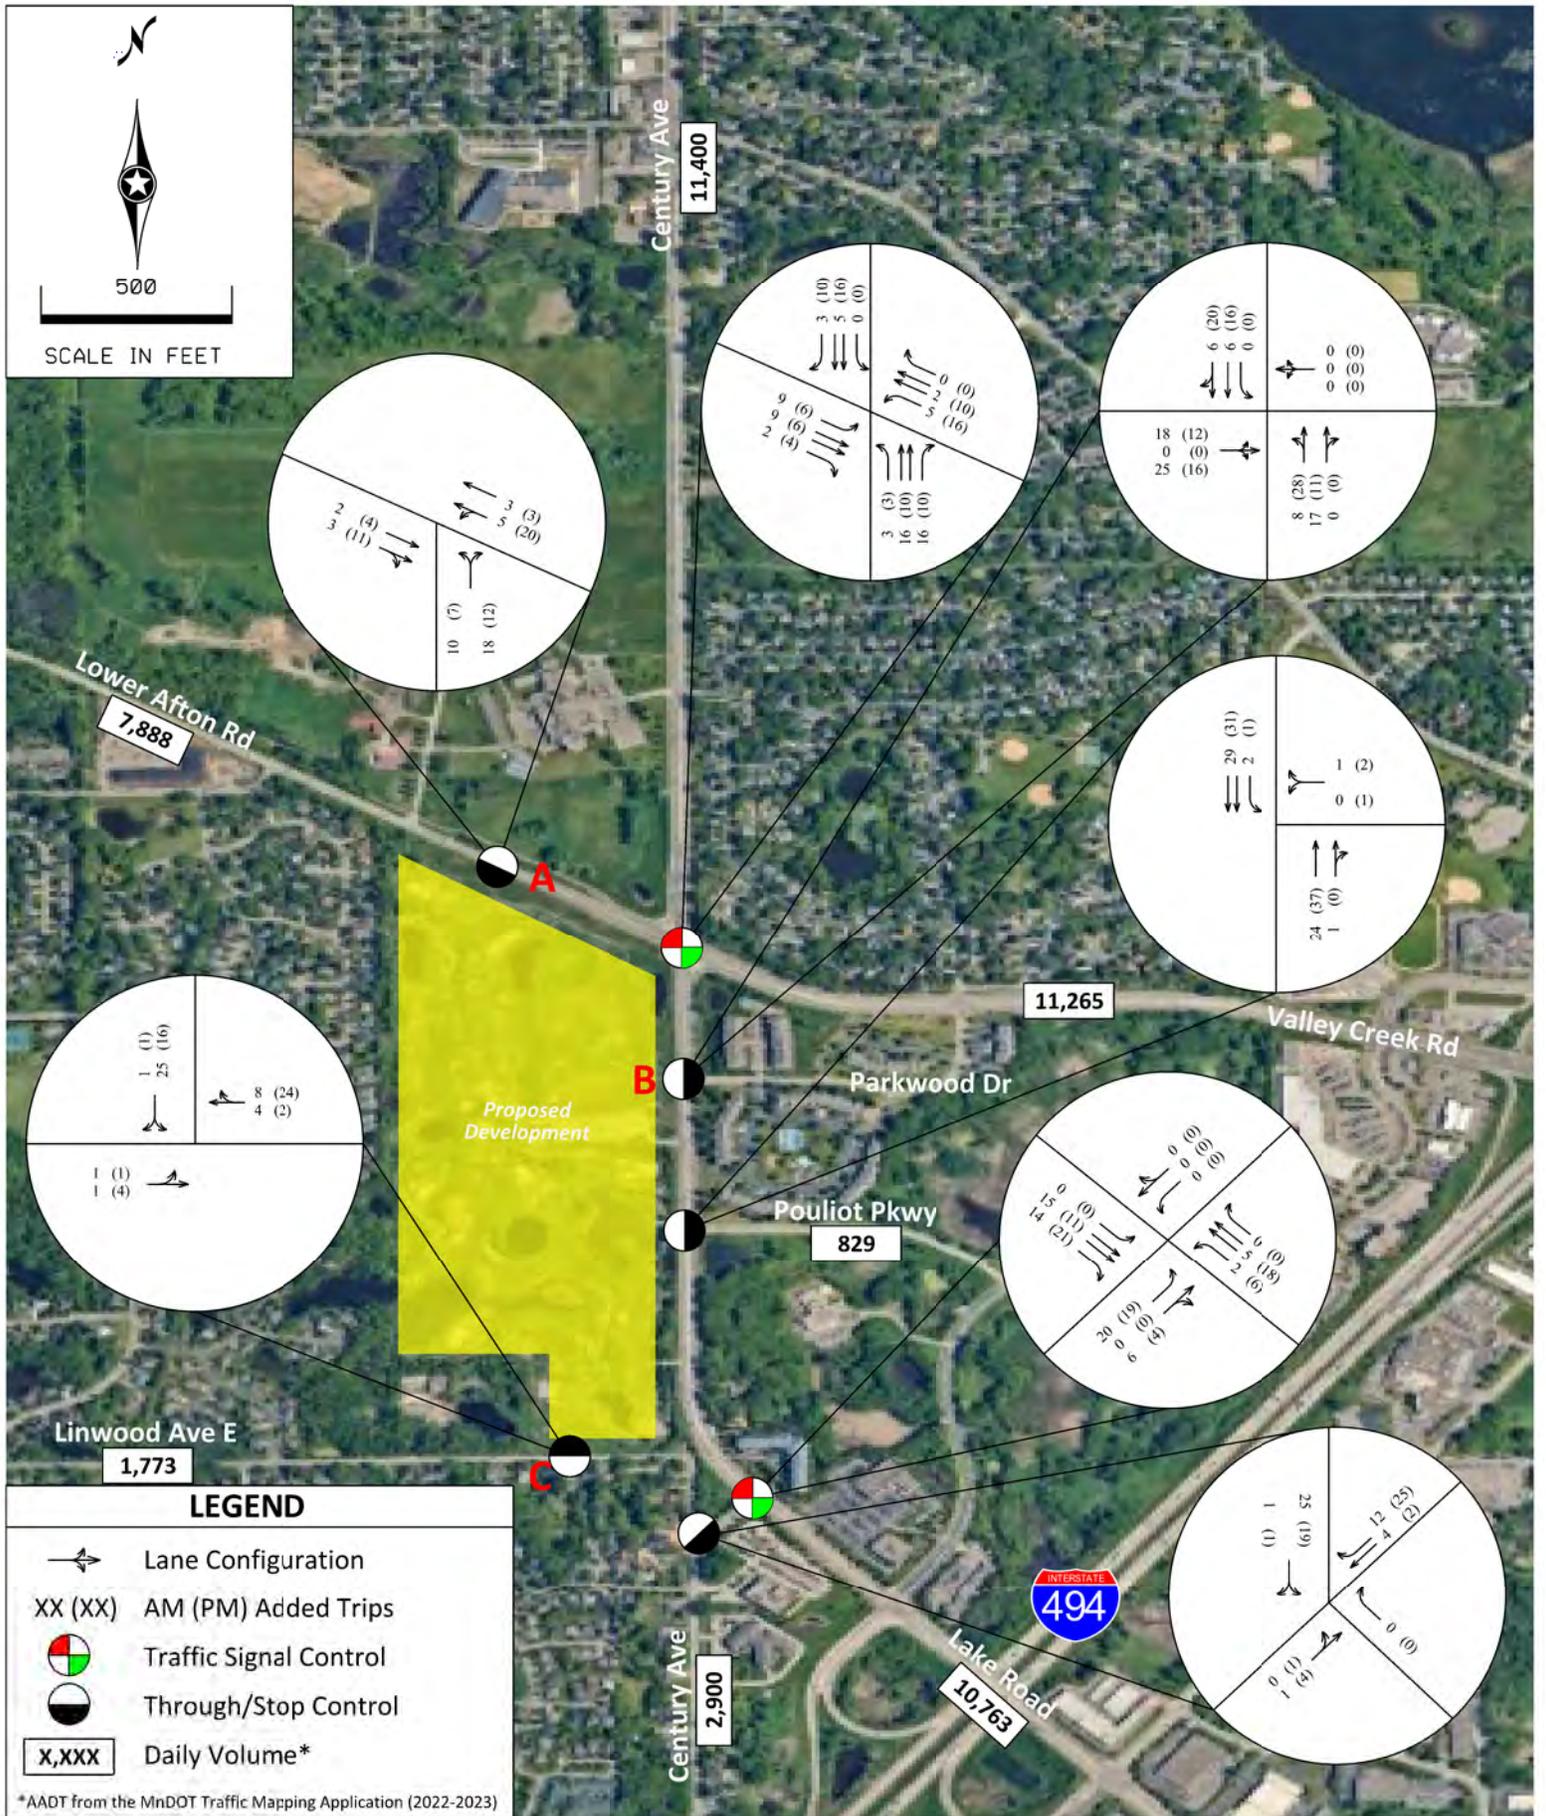
Figure 5
Added Trips
