**ENVIRONMENTAL & NATURAL RESOURCES COMMISSION STAFF REPORT**  
Meeting Date October 8, 2025

**AGENDA ITEM:** Century Ponds Proposed Development, 601 Century Avenue South  
– Wetland Buffer Variances

## **CENTURY PONDS**

### **Comp Plan Amendment, Preliminary Plat, Rezoning, PUD Maplewood, MN**

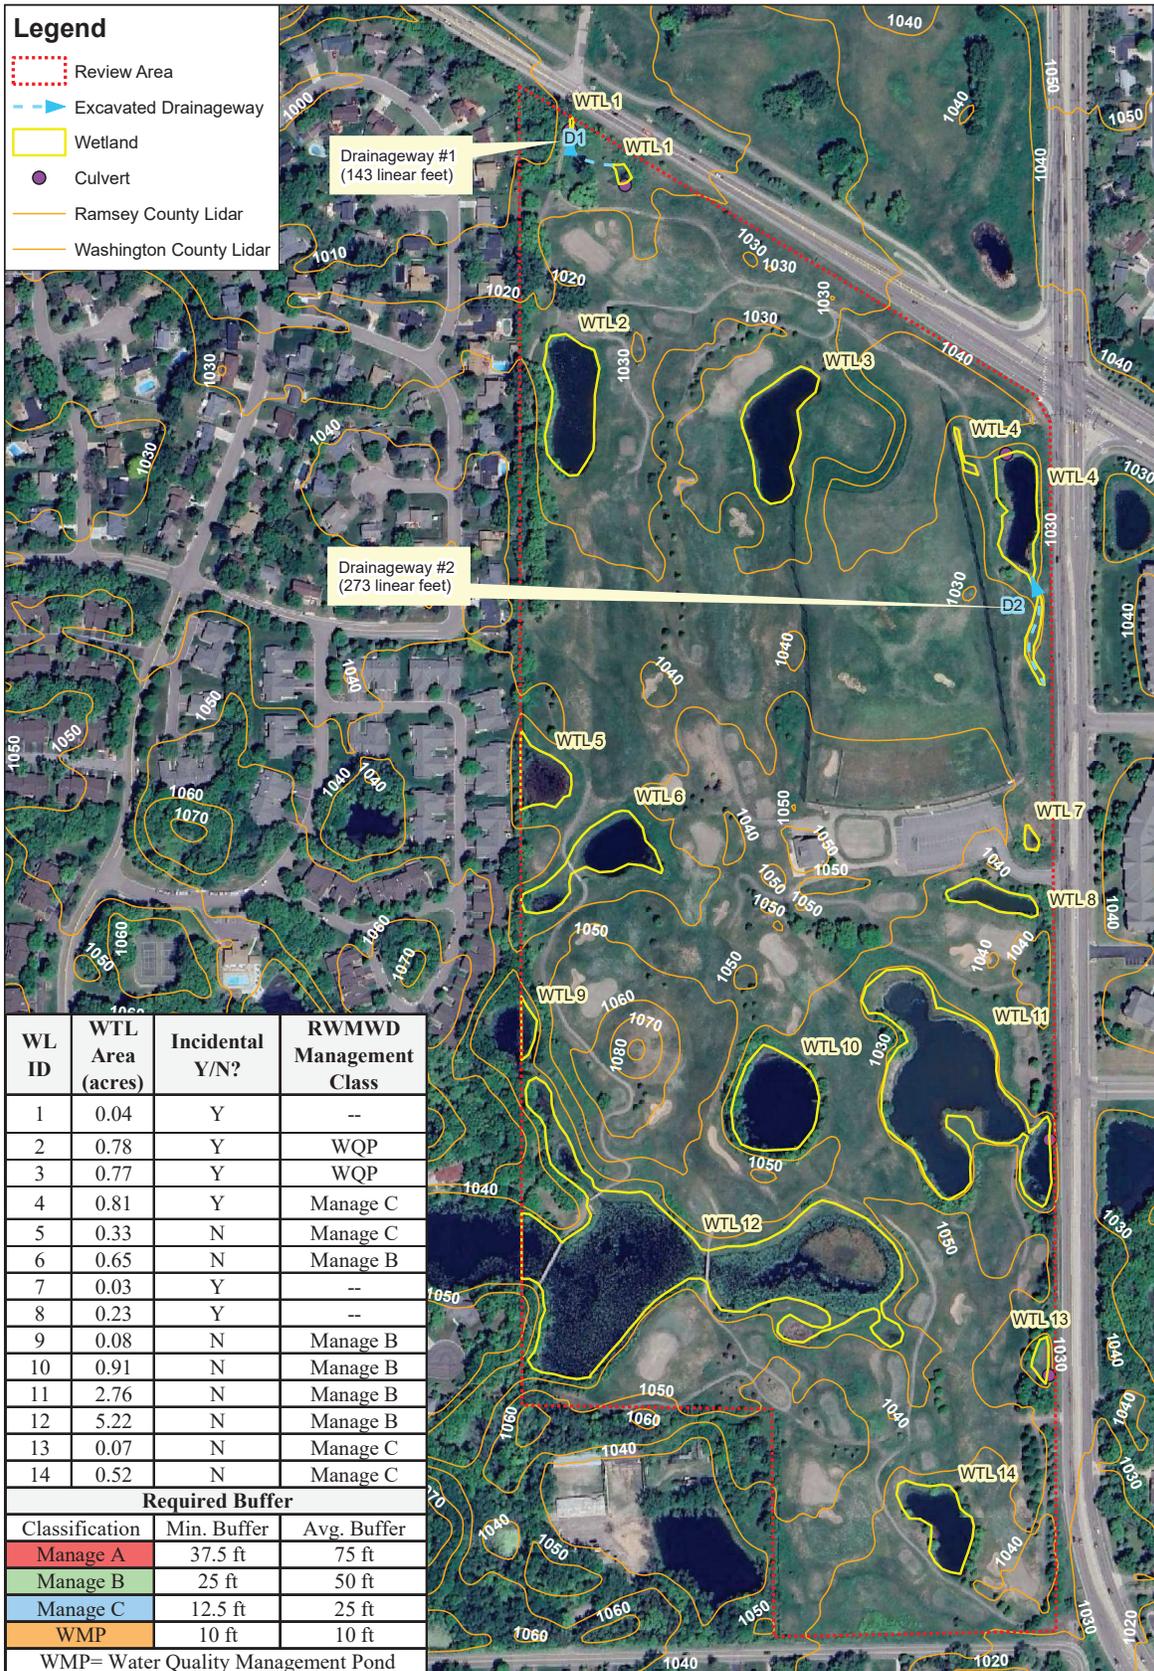
Figure 2A - Existing Conditions (5/25/2023 Google Earth Photo)

Fourteen (14) wetlands were delineated within the site boundaries. The delineated wetland boundaries and existing conditions are shown on **Figures 2, 2A, and 2B**.

Potential wetlands were evaluated during field observations on November 1<sup>st</sup> and 2<sup>nd</sup>, 2023. Fourteen (14) wetlands were identified and delineated on the property (**Figure 2**). Corresponding data forms are included in **Appendix B**. The following description of the wetlands and their adjacent upland reflects conditions observed at the time of the field visit. At that time, some vegetation was still growing, while some had senesced. Precipitation conditions were normal (typical) based on the three-month antecedent precipitation data for a date of November 1<sup>st</sup>, 2023, and above the normal range based on the 30-day rolling total. In the two weeks leading up to the site visit, 1.85” of precipitation fell (**Appendix C**). Delineated wetland characteristics are summarized in **Table 2** (see pages 6 and 7).

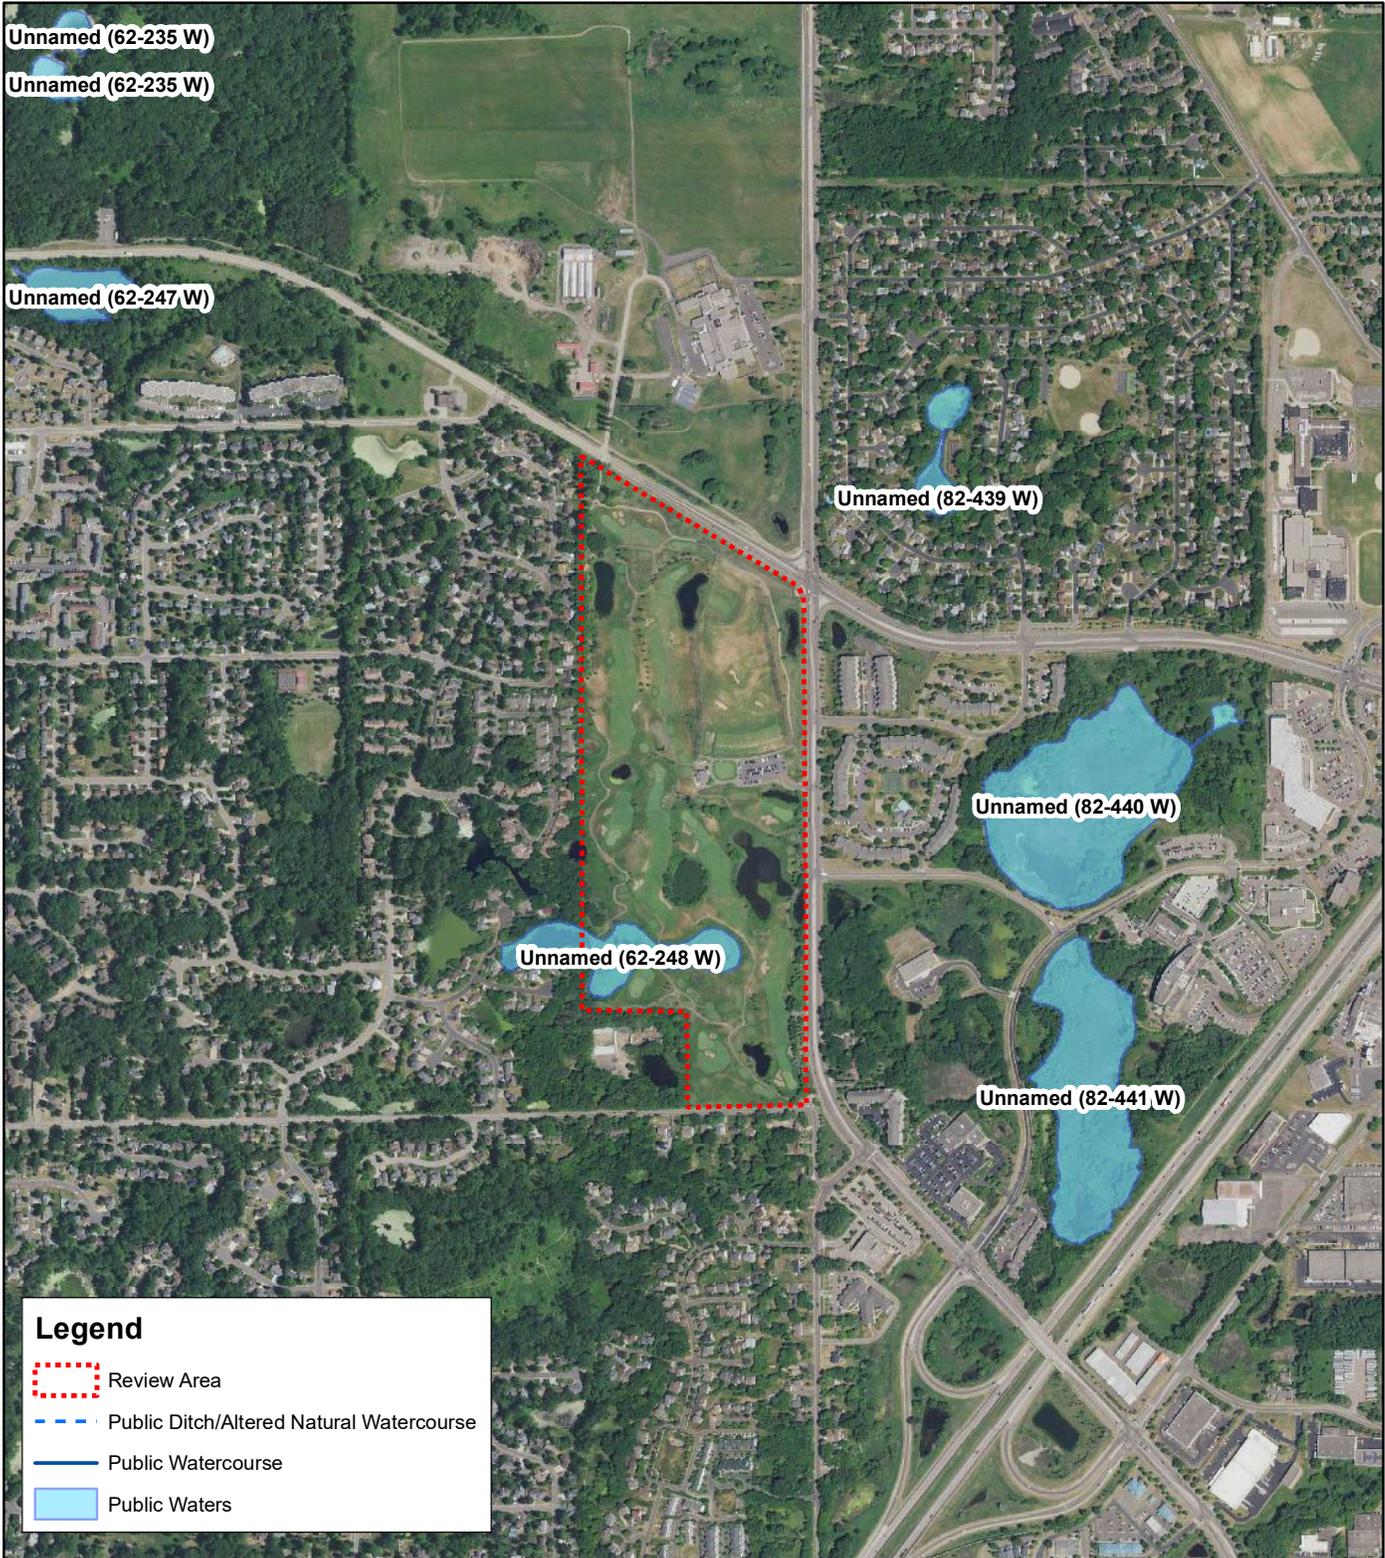
**Figure 5 - DNR Public Waters Inventory**

The Minnesota DNR Public Waters Inventory (Minnesota Department of Natural Resources 2015) identified DNR Public Water Wetland 62-248 W (unnamed) within the review area, two unnamed DNR Public Water Wetlands (62-439 W and 82-440 W) within 1,000 sf of the review area boundaries, and an unnamed DNR Public Water Wetland within 1,200 sf of the eastern review area boundary (**Figure 5**).

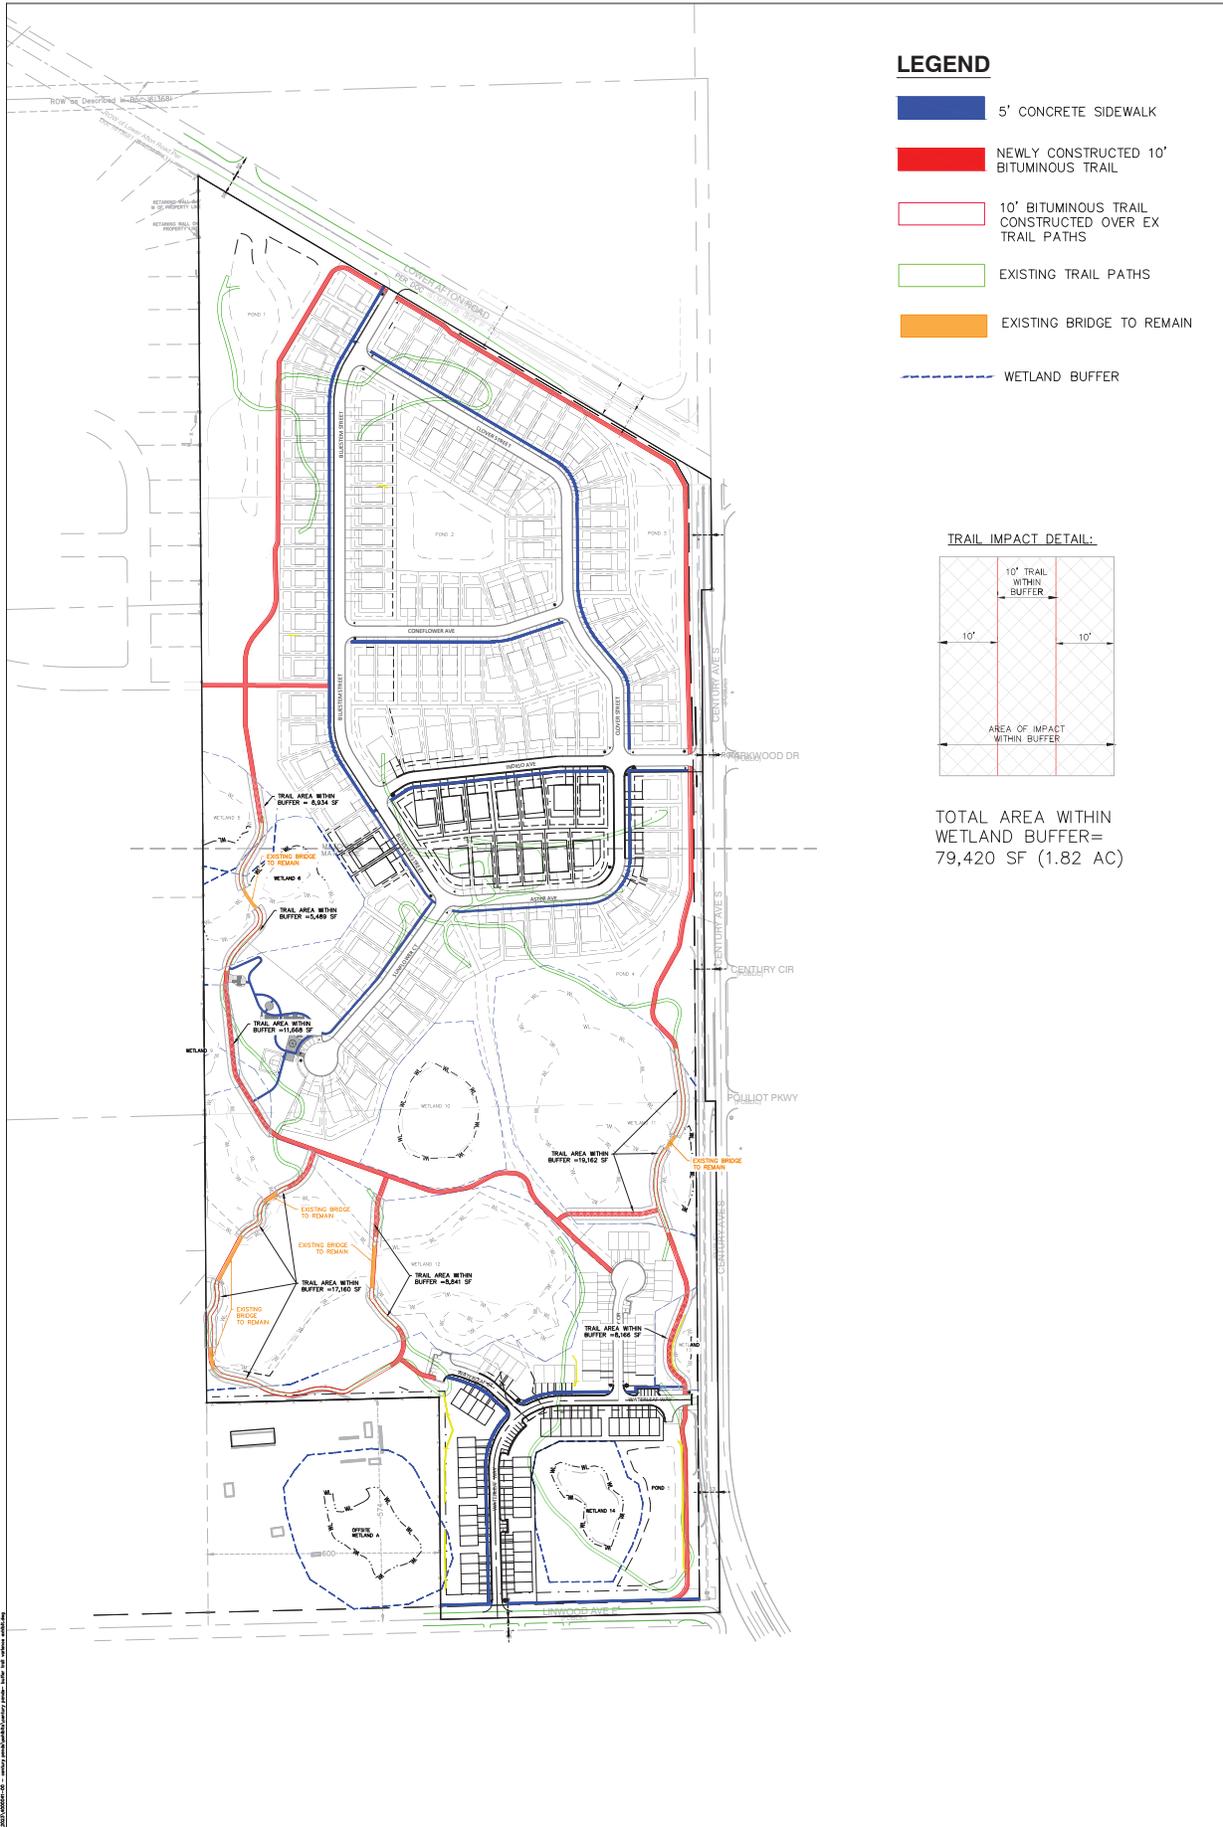
**TRAIL IMPACTS TO WETLAND BUFFERS**  
 MAPLEWOOD, MN

2. **Trails:** There are existing paved golf cart trails located within required wetland buffers that will be used as walking and biking trails in the new development. Some of the trails will be removed and rerouted, and additional trail links will be added. The wetland ordinance allows for public trails in wetland buffers if they are designed and constructed with sustainable design methods. To achieve this, City staff recommend a 5-foot strip of grass adjacent new and existing trails outside of the wetland buffers, and a 5-foot strip of grass and a 10-foot strip of native plantings adjacent new and existing trails within the wetland buffers. This will allow trail maintenance and stormwater runoff to filter into the native plants prior to entering the wetland.

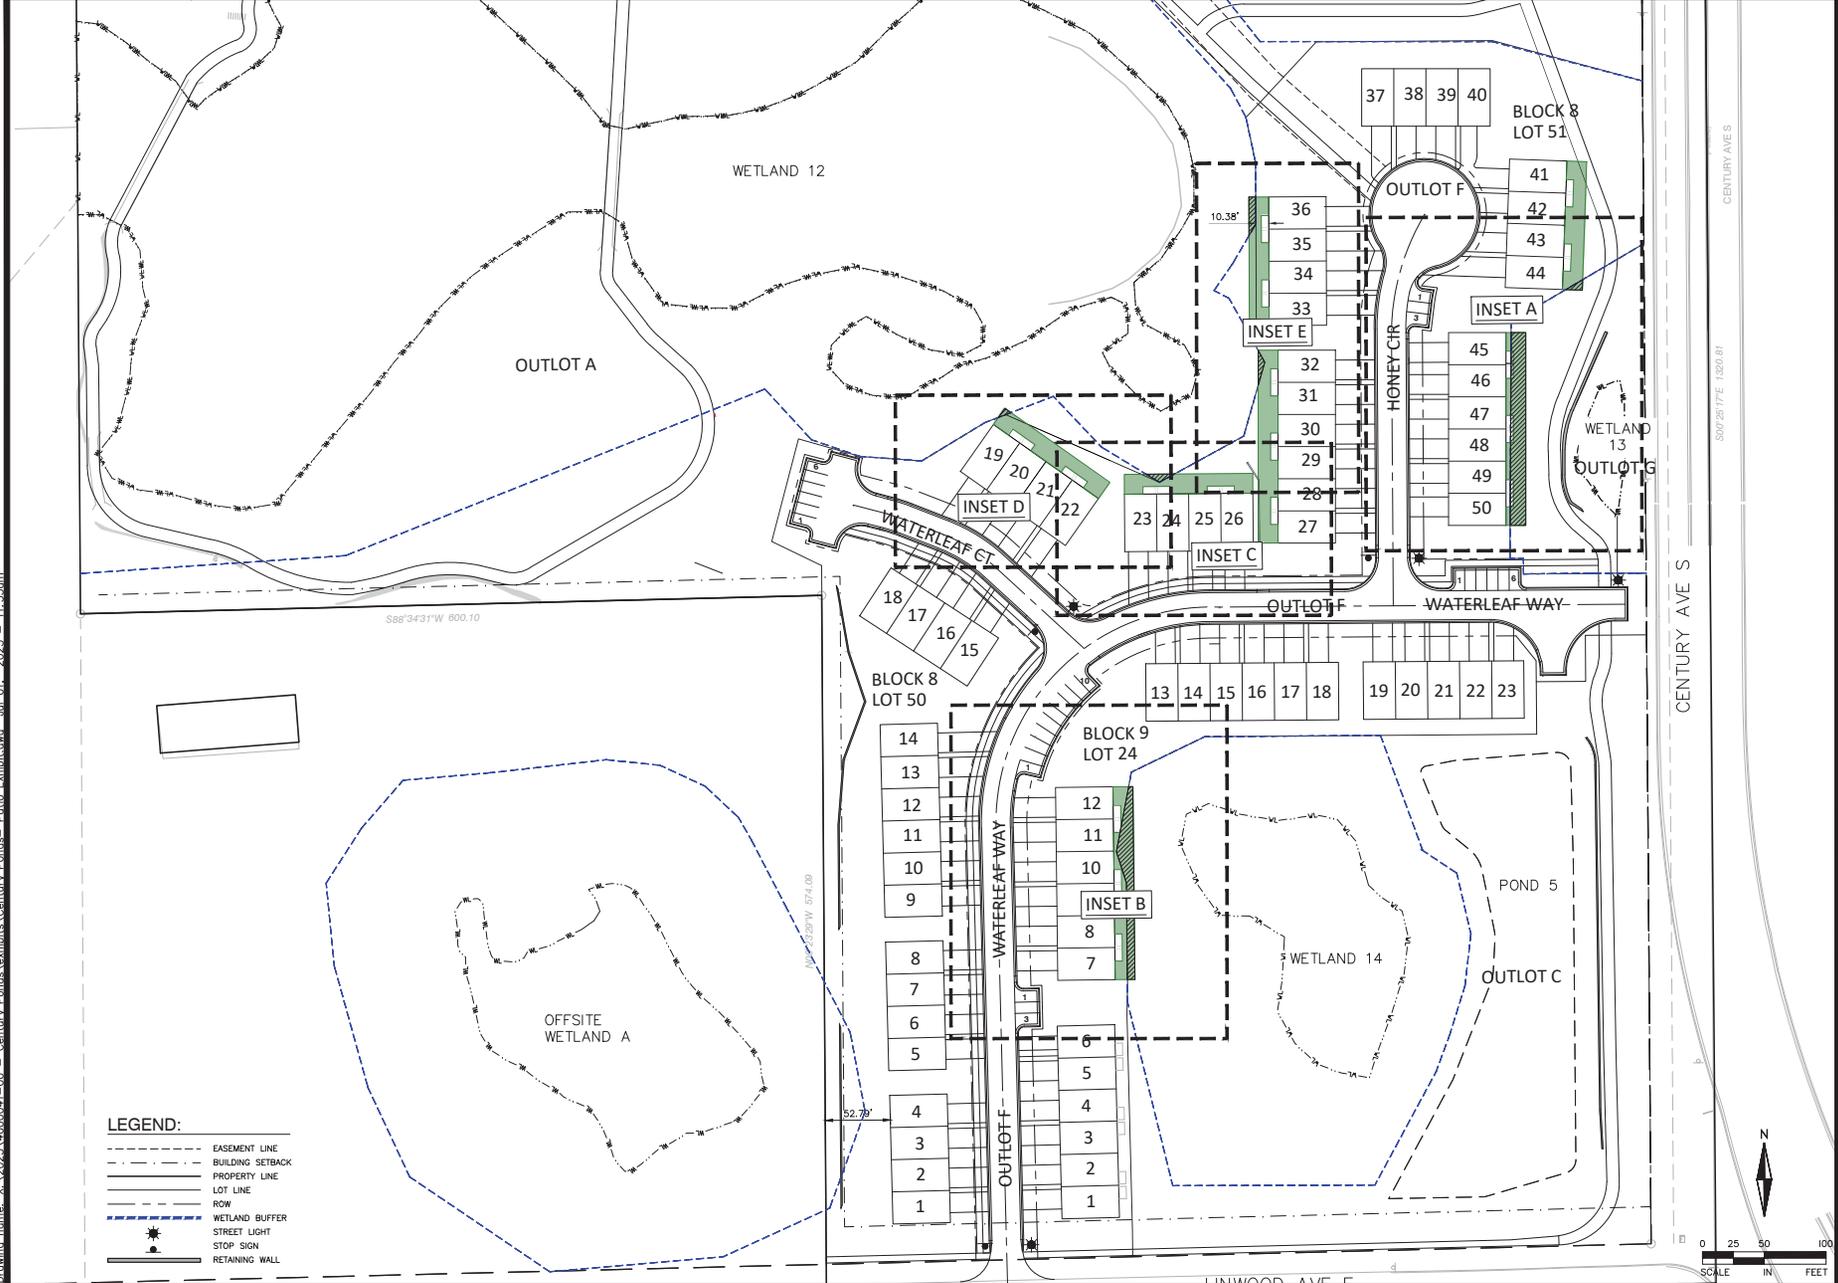
**CENTURY PONDS**  
 MAPLEWOOD, MN  
**PRELIMINARY PLAT**  
**PATIO EXHIBIT - OVERALL**

1. **Townhouse Patio and Yard Area Encroachments:** Several of the townhouse patios will encroach into the wetland buffers. To ensure these homes have a small, manicured yard behind their homes and patios, staff recommend at least a 15-foot strip of grass on the back side of the townhomes. This will create a useable yard area to access the back of the buildings and patios. The applicant submitted a Patio Exhibit which reflects these encroachments. However, it is unclear if these encroachments are accounted for in the Wetland Buffer Area Variances identified in the Wetland Buffer Details table above.

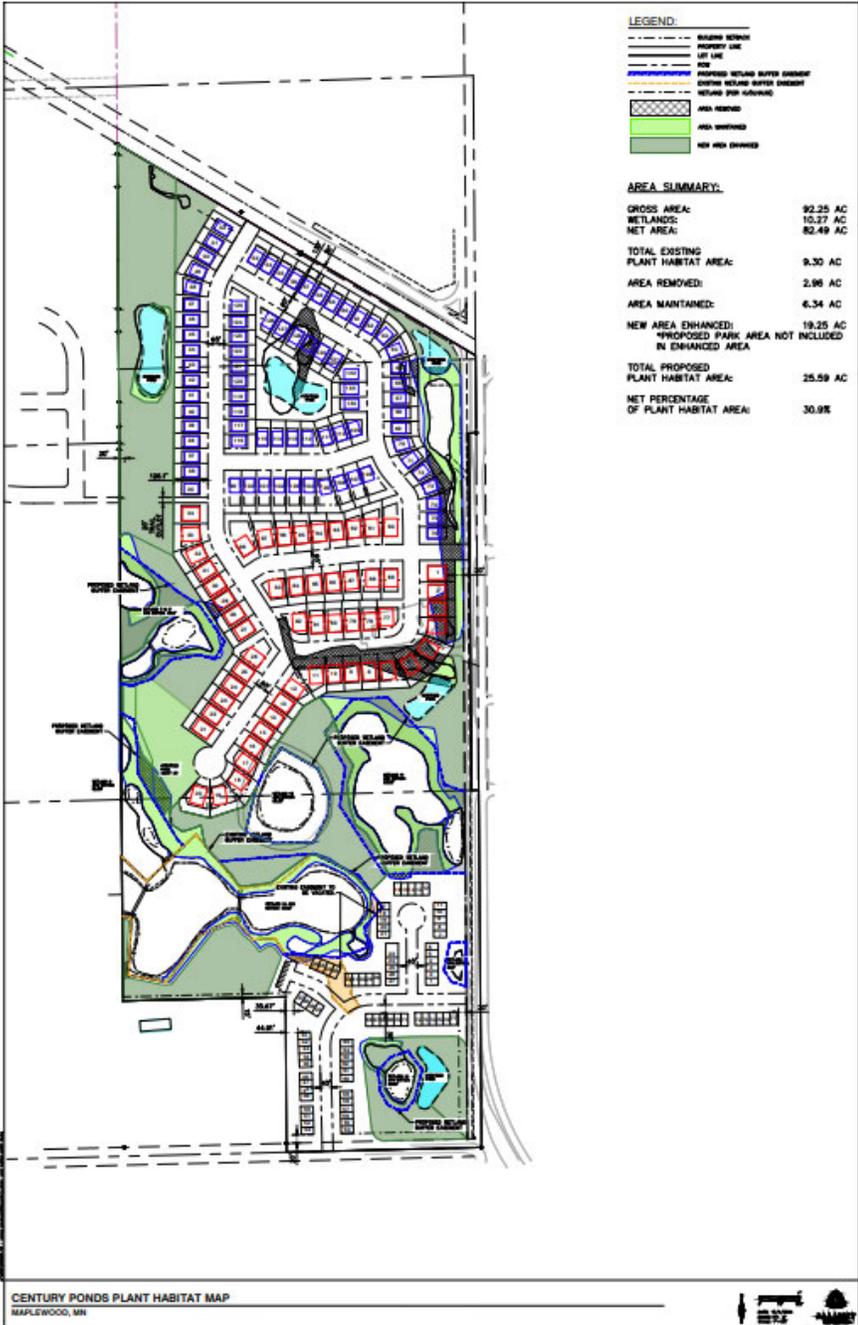
## Project Dimensions & Planting Zones

3. Following initial grading (done by others) the site will be treated with herbicide to kill existing weeds, tilled, and harrowed to provide a smooth seedbed, seeded with native grasses and wildflowers, and mulched with straw and anchor disked/covered with straw erosion blanket to protect the seeding and enhance germination.

1. The Native Seeding Project Area is approximately 25.59 Acres  
With 6.34 Acres of Maintained area and 19.25 Acres of New installation areas
2. Depending on condition and the number of native species present of maintained areas restoration techniques may vary in some cases a full restoration will be needed.

Prairie Restoration LLC submitted a native landscape restoration plan for the wetland buffers and open space sites in the development. Areas graded as part of the overall development will be treated with herbicide to kill existing weeds, tilled, and harrowed to provide a smooth seedbed, seeded with native grasses and wildflowers, and mulched with straw and anchor disked/covered with straw erosion control blanket to protect the seeding and enhance germination. The proposed seed mixes are specifically created for Rusty Patch Bumble Bee habitat. Existing naturalized areas that will not be graded will have all invasive woody species removed by flush cutting and stump treating with herbicide, prior to seeding. In areas near water, an aquatic-approved glyphosate herbicide will be used. The upland areas will then be seeded with native prairie grasses and wildflowers adapted to the well-drained, sunny conditions. The riparian areas will be seeded with wetland grasses and flowers that are adapted to the saturated soil conditions.

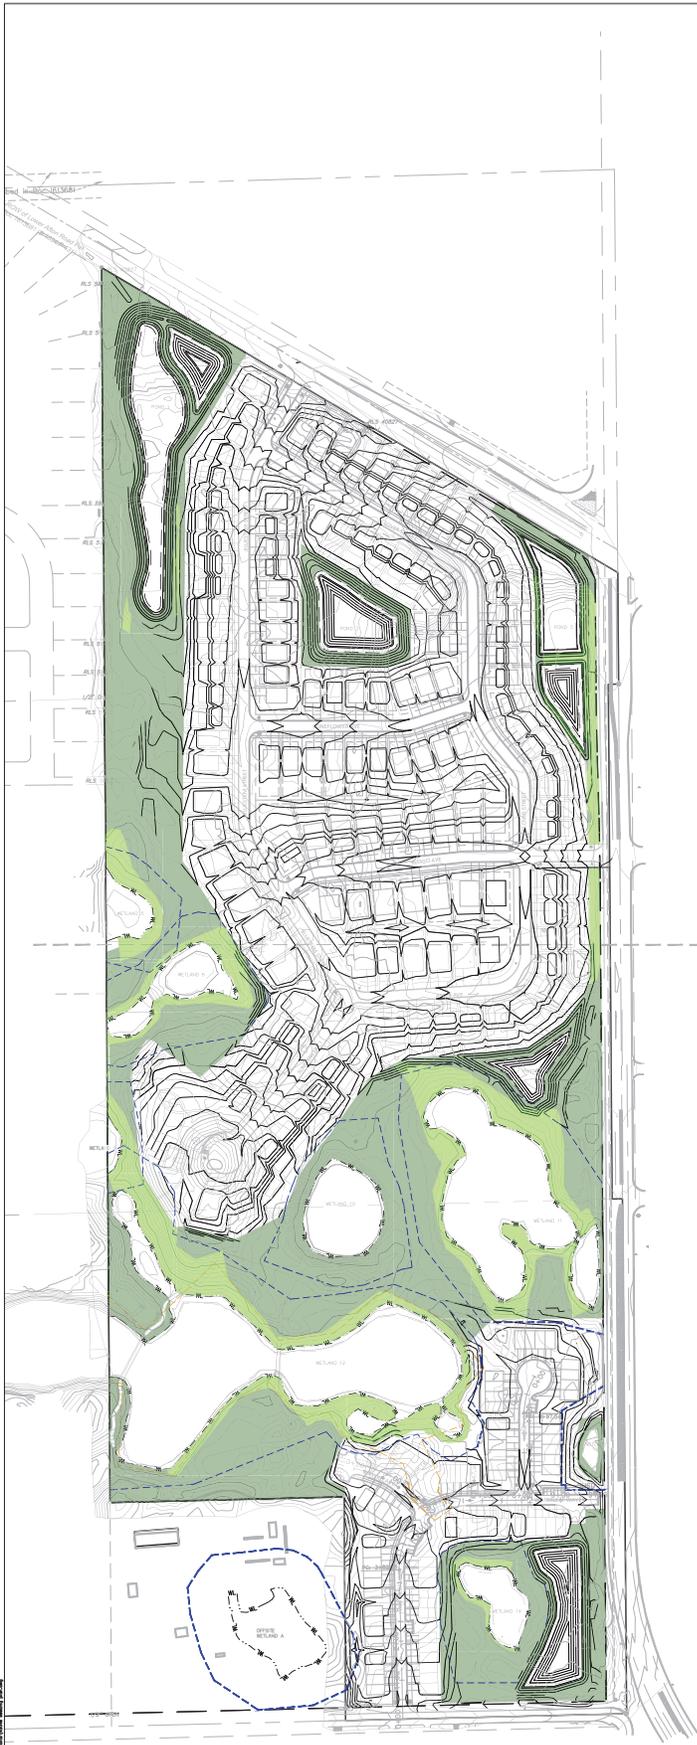
**WETLAND BUFFER CALCULATIONS:**

- EXISTING HABITAT AREA TO BE MAINTAINED (6.12 AC)
- NEW PROPOSED ENHANCED AREA (22.10 AC)
